Technical Report No. CF7

BELLBIRD COLLIERY

The recovery of the No. 1 Tunnel following an underground fire

BY J. G. BAILEY, Inspector of Collieries

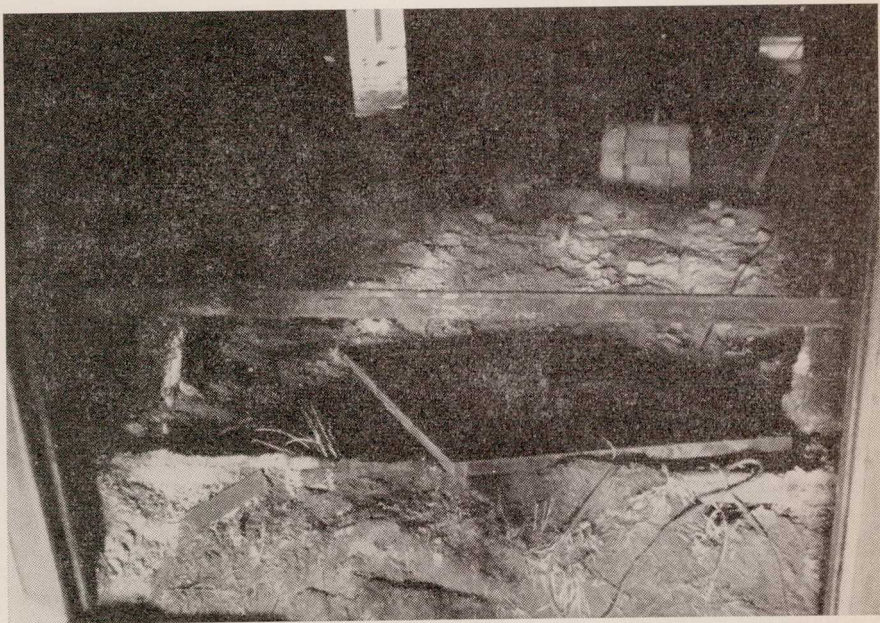
Work then began to complete the seal over the upcast shaft by covering the planks with brattice and applying 6 inches of loam. When this was completed, the fan was stopped. The time was 5 a.m. on 22nd December, 1963.

Seal over upcast shaft. (24th December, 1963.)

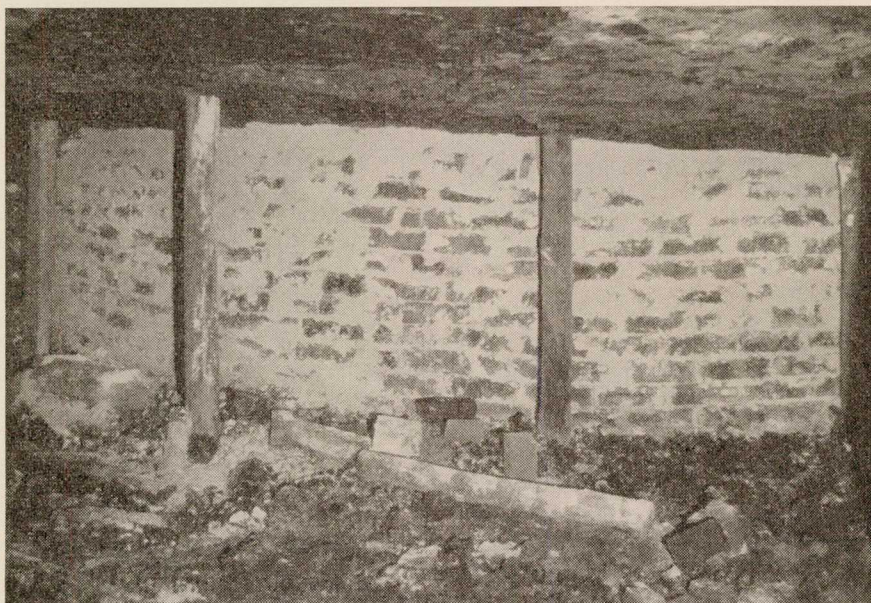
Seal at C. (11th March, 1964)

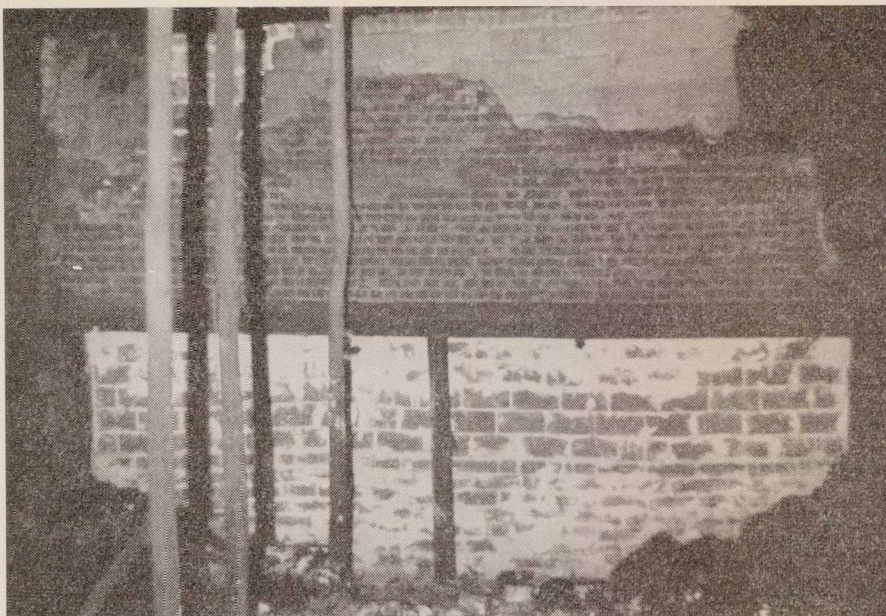
Seal at E under overcast. (11th March, 1964)

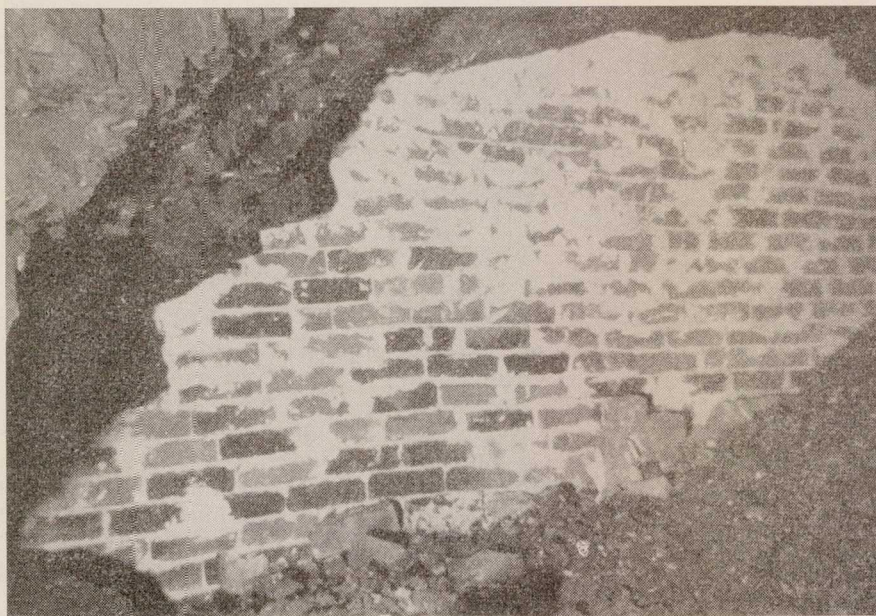
Seal at F. (11th March, 1964)

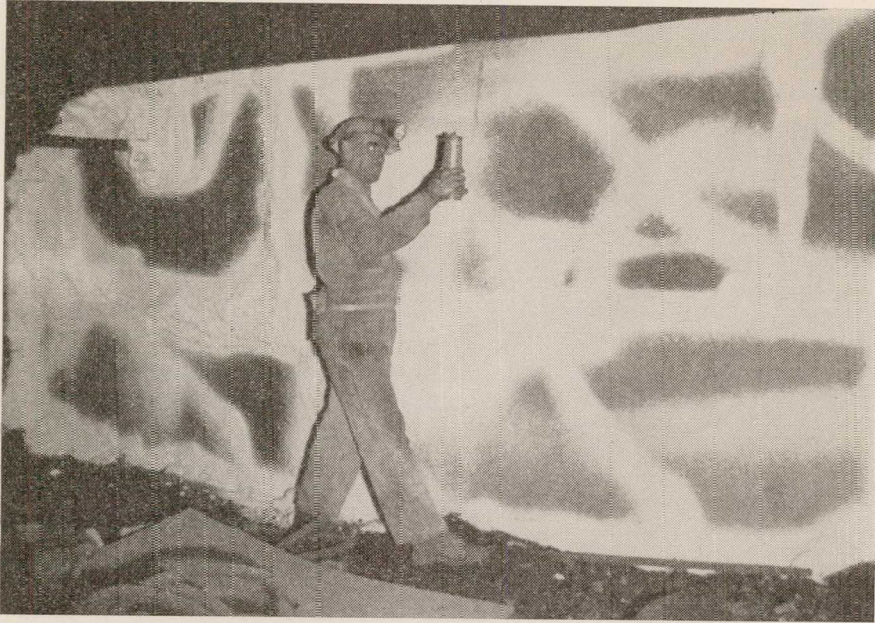
Seal at G. (11th March, 1964)

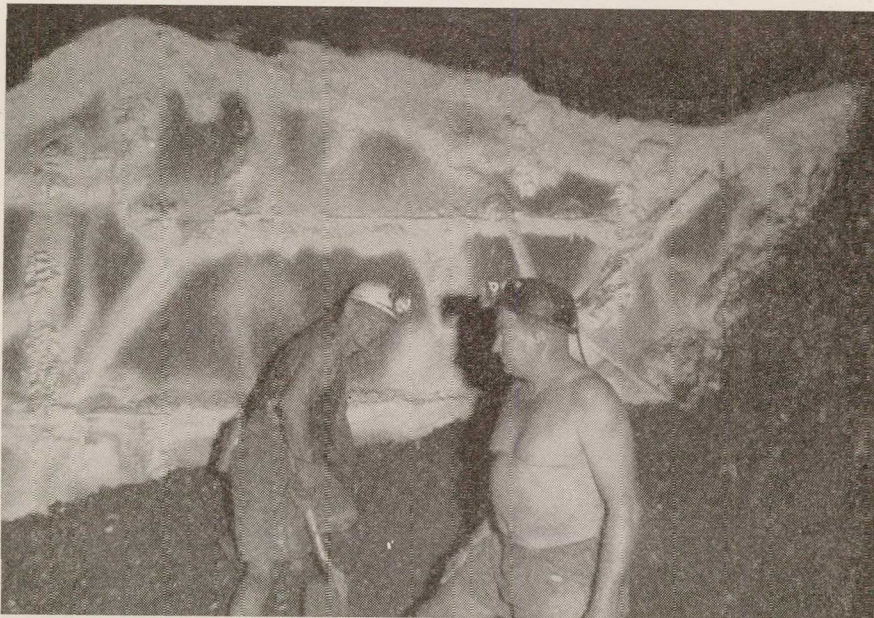
Seal at H. 11th March, 1964)

All the reclamation personnel began work to erect a 16 in. brick seal outbye of temporary seal H. This involved the transport of bricks and mortar, the removal of 6 ft. of loose coal to expose the seam floor and the laying of the concrete blocks. When work ceased at 5 p.m. that day, about one-quarter of the bricks necessary for the 12 ft. high seal had been set.

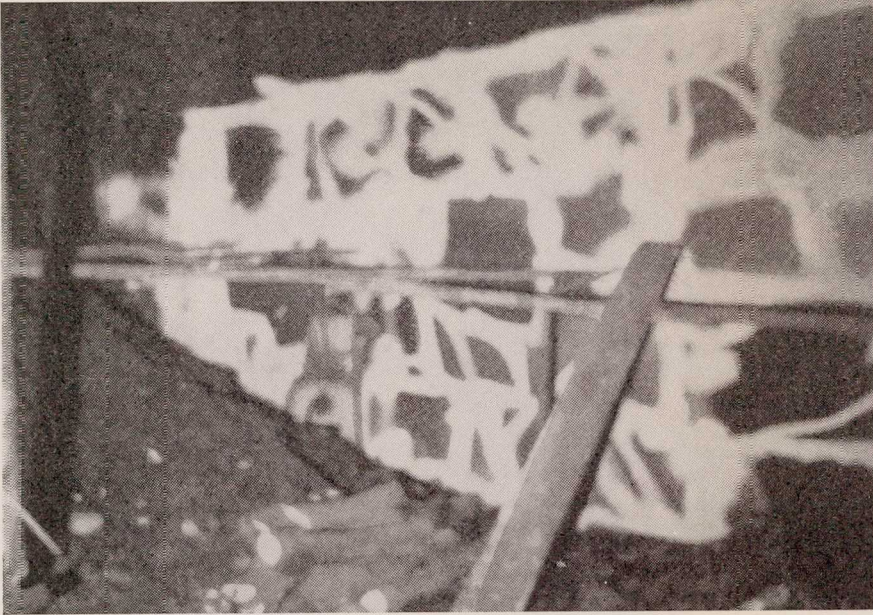
Seal at I. (11th March, 1964)

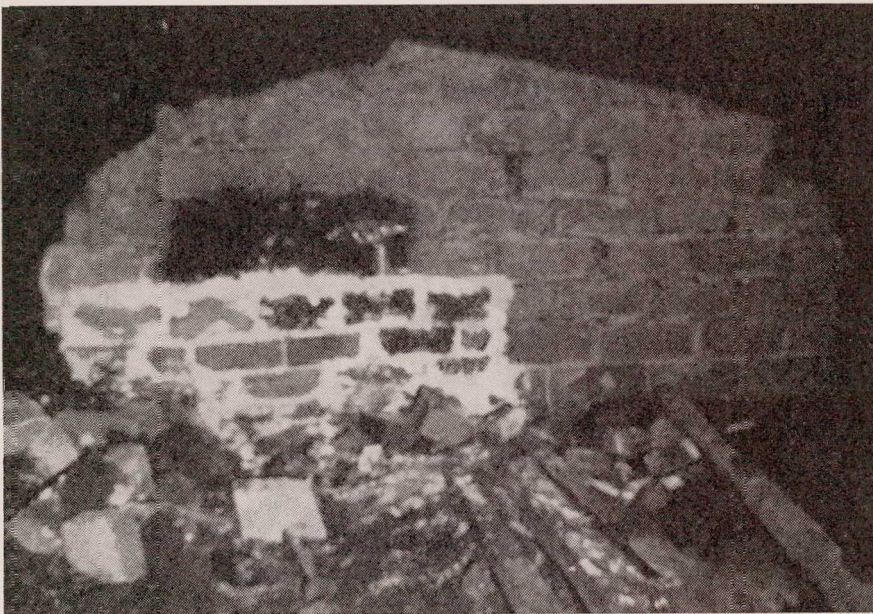
Seal at J. (11th March, 1964)

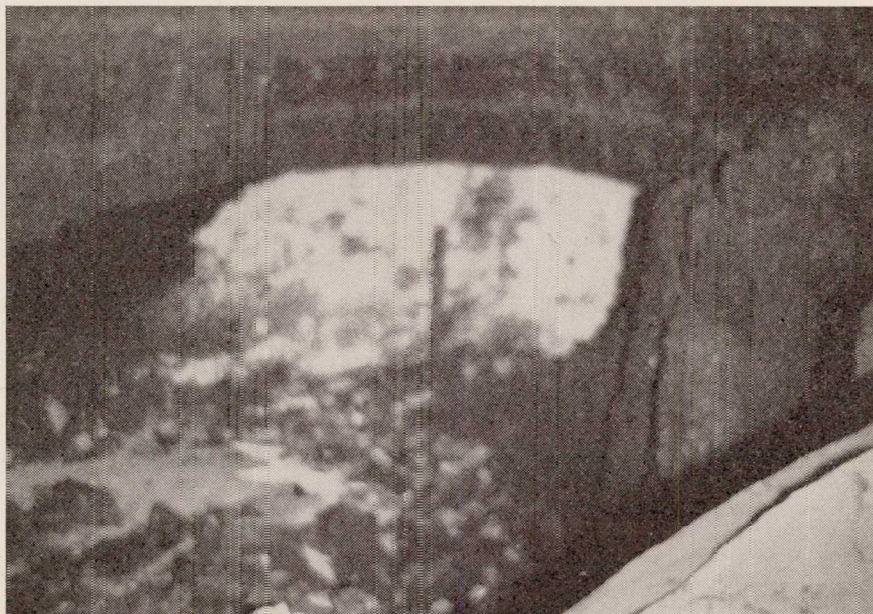
Stowage pack at K. (11th March, 1964)

During the day, the stowed pack at location K was supplemented with additional material and covered with stone dust. This seal was observed to be leaking when completed but was not considered to be excessive. Work also continued with the brick seal at H and when work ceased for the day, was within 2 ft. of the roof. The temporary masonite seal H remained at approximately blood temperature, and during the day a sulphur smell was detected and attributed to the dust in suspension caused by the workmen in this vicinity.
