Salt attack and rising damp

A guide to salt damp in historic and older buildings

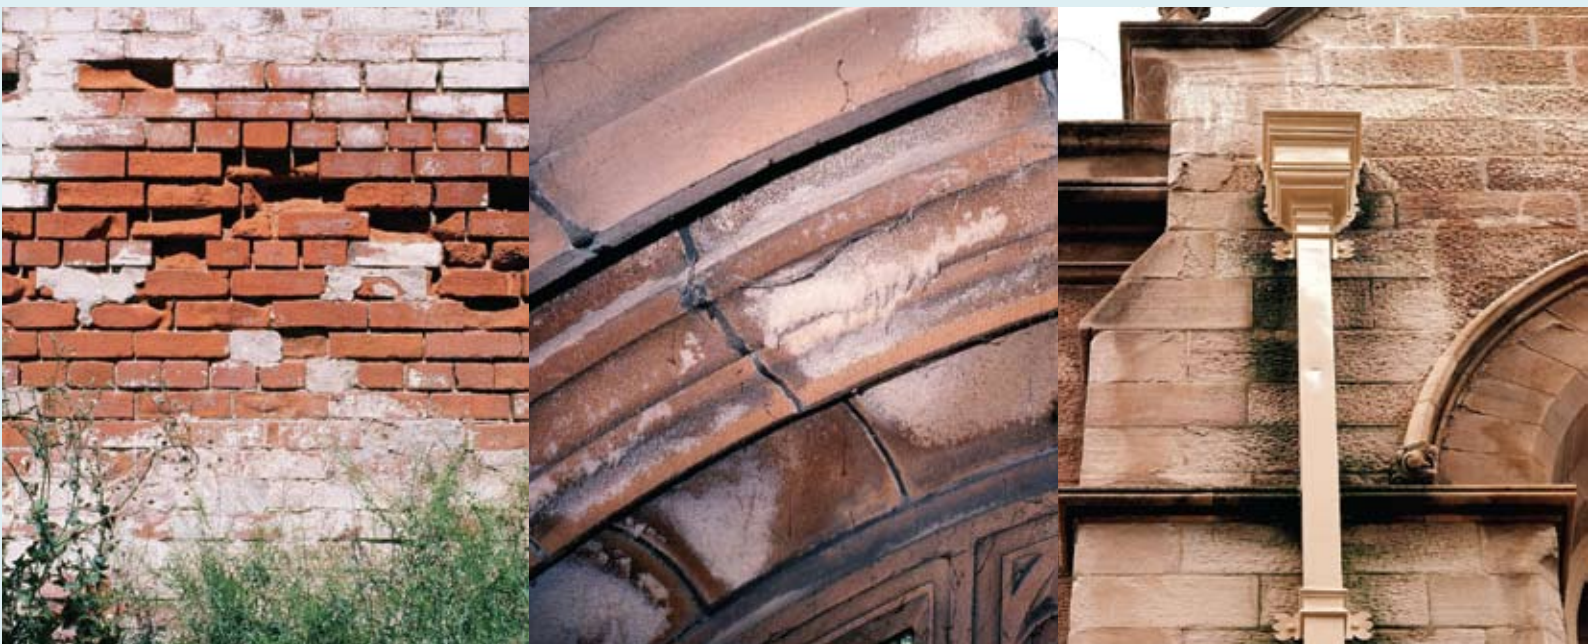
This guide aims to provide owners, consultants and contractors with sufficient information to understand what causes salt attack and rising damp (and also falling and penetrating damp) and to diagnose and identify appropriate repairs for cases commonly seen in Australia. While emphasis is given to buildings of heritage value, the principles apply to all older buildings.

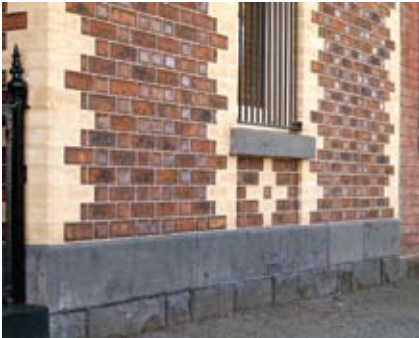
Figure 1 The dense bluestone base courses of this Melbourne building help reduce upward movement of moisture. Dense stones such as bluestones and granites are commonly seen as base courses around Australia.

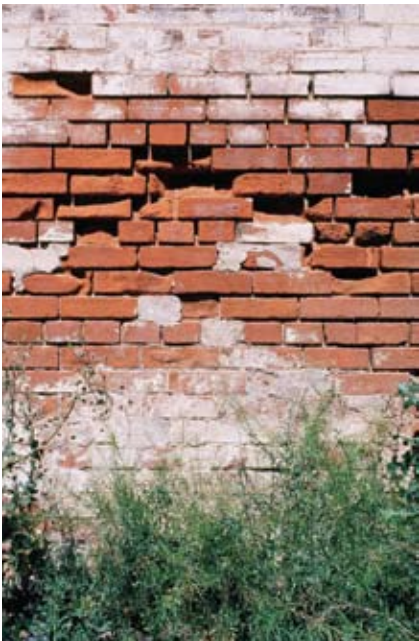
Figure 2 Typical salt damp damage in Adelaide, with decay of the bricks extending from about 0.5 to 1.2 metres above ground. There are no obvious signs of salt because it has been washed off by rain. Paler (underfired) bricks are more susceptible to salt attack than the darker, more well-fired ones.

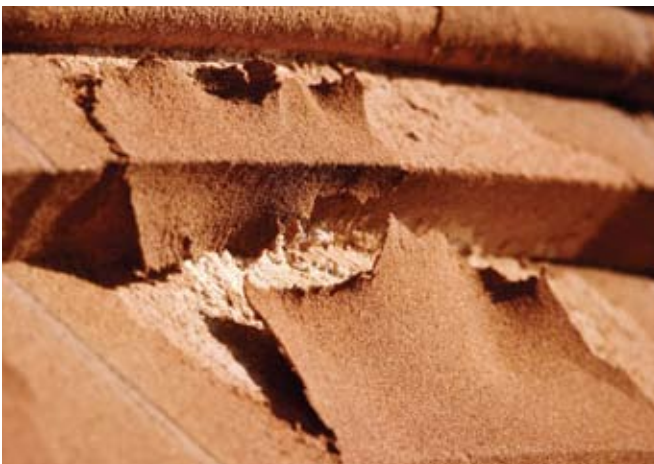
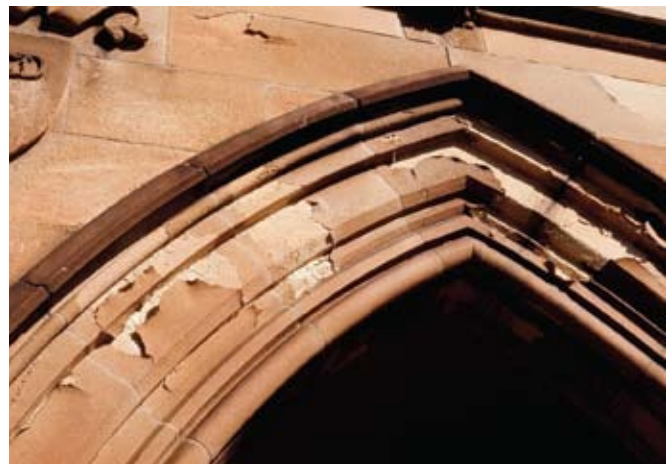
Figure 3 Inappropriate use of water repellent coating, trapping moisture and salts and causing loss of the sandstone's natural case-hardened surface. Beneath this 'skin' the stone can be quite weak.

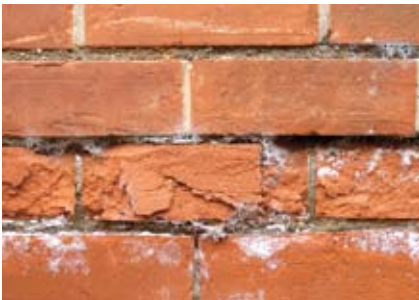
Figure 5 Salt attack in bricks causing disruption and loss of the fireskin, the harder outer surface that develops during firing in the brick kiln.

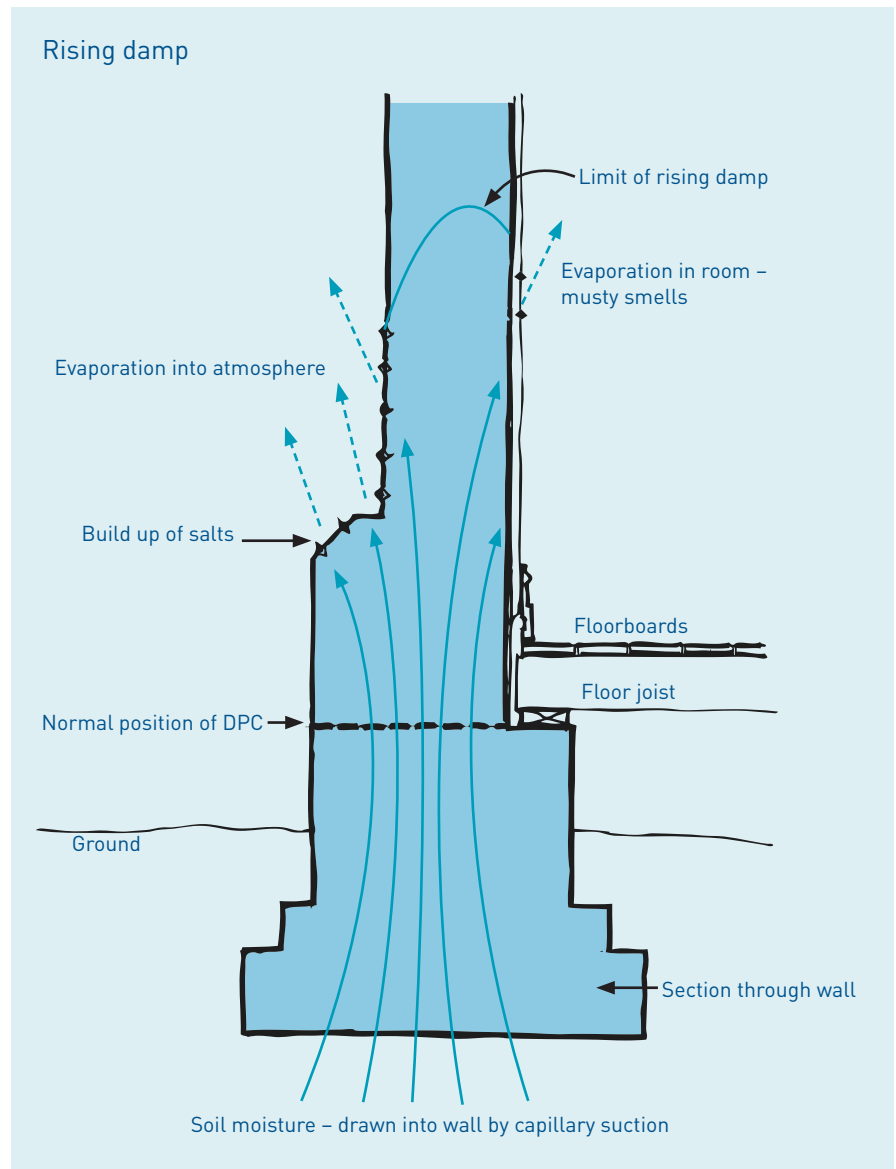
Rising damp is caused by capillary action (or suction) drawing water from the ground through the network of pores in a permeable masonry material. Capillary suction becomes stronger as the pore size gets smaller; if the pore size is fine enough damp may rise many metres in a wall, until the upward suction is balanced by the downward pull of gravity (Figure 6).

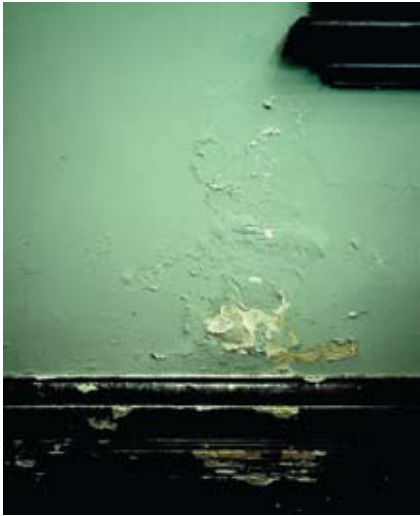
Figure 7 Typical blistering of paintwork and damage to internal plaster due to the combined effects of rising damp and salt attack. The skirting is a cement moulding and also shows salt damage.

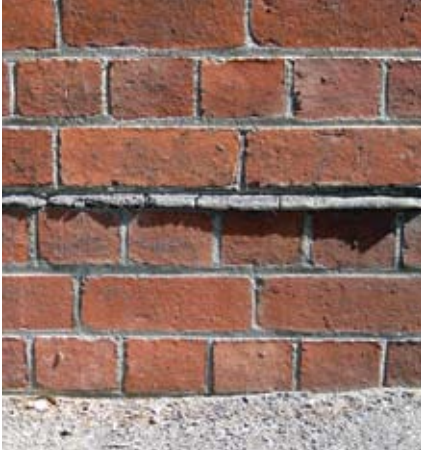
Figure 8 Many late nineteenth and early twentieth century DPCs were a mix of tar and sand that was laid hot. Being viscous, some have harmlessly extruded a little under the weight of the overlying masonry.

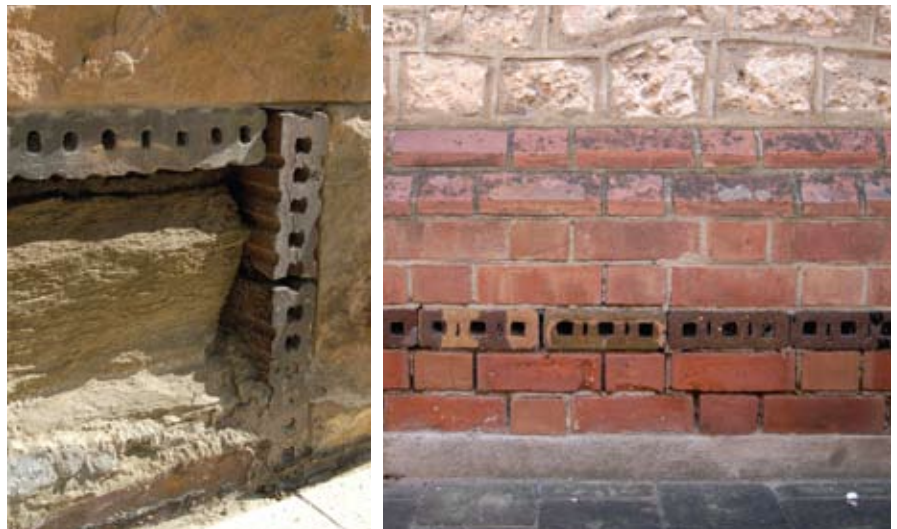
More recent DPCs have included thin copper or aluminium sheets coated with bitumen and then with talc or mica flakes to prevent adhesion when rolled. These have not performed well in corrosive (i.e. salty) environments. There is also a composite DPC which has a metal core coated in bitumen with an external coating of polyethylene. Because the plastic coating is very thin (0.1 mm) it is easily damaged, exposing the metal which is then susceptible to corrosion. Waterproofing additives for mortars have been commonly used, generally in the first three courses of brickwork above the concrete footing. Mortar additives should not be relied on as a sole means of damp-proofing.

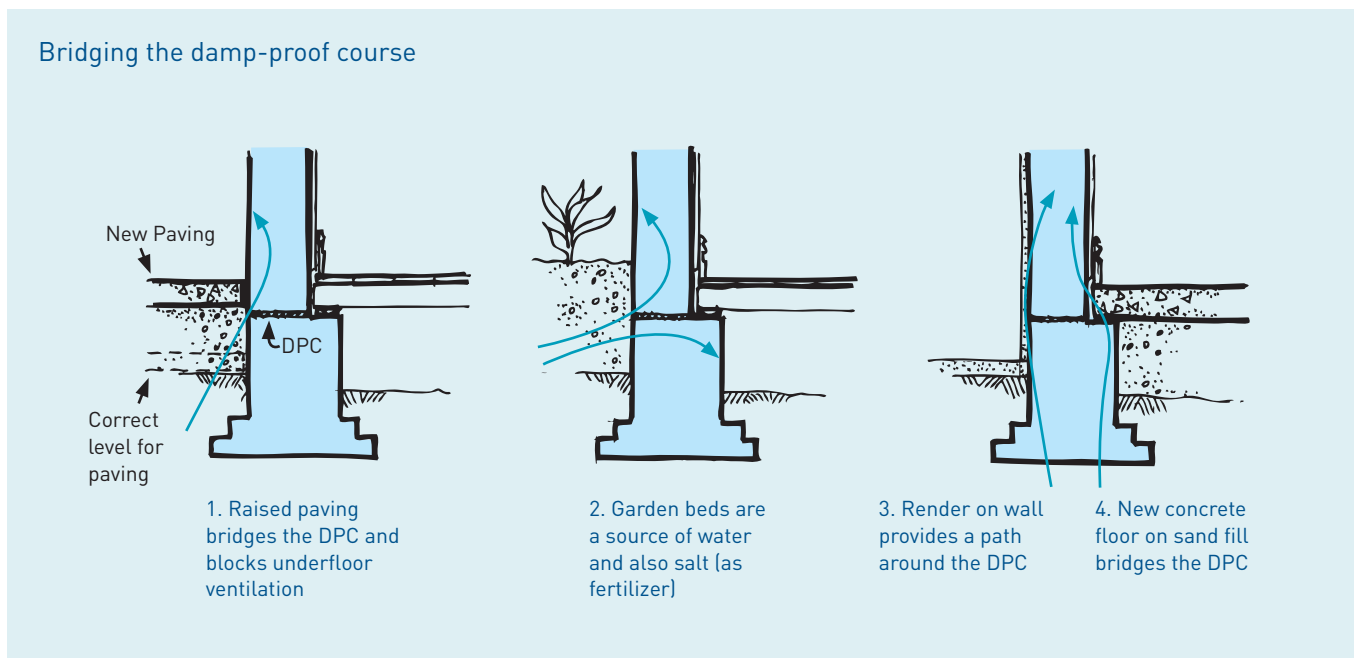
Figure 11 Bridging the damp-proof course. Four examples of how changes to a building can create a path, or bridge, around an existing damp-proof course. Bridging by build-up of paving or garden beds is a common cause of rising damp problems. See also Figures 29 and 49 for further examples of bridging.

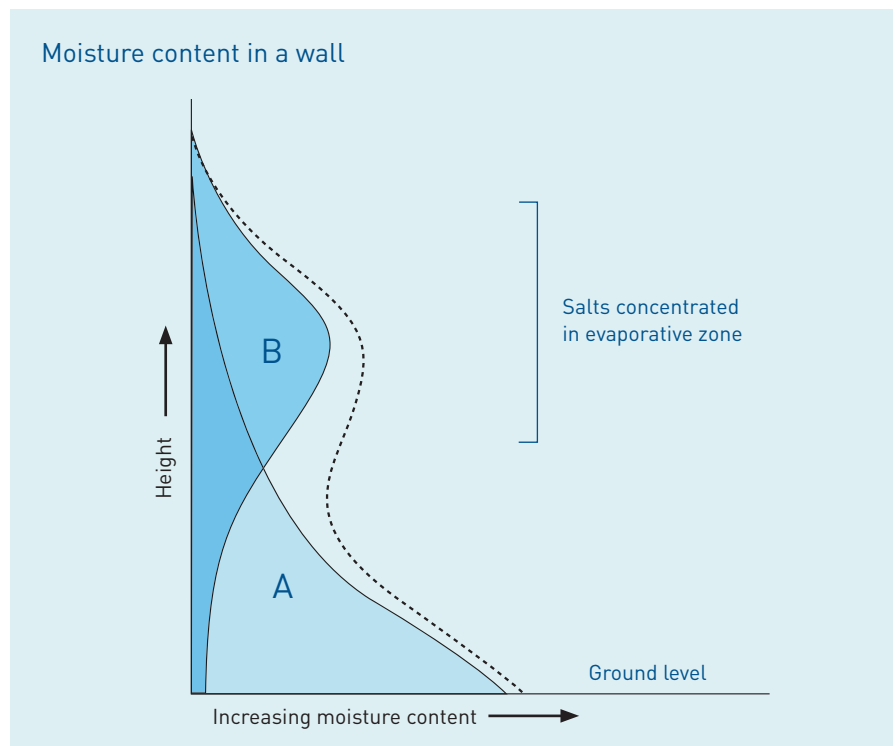
Most damp-related decay is caused by salt attack in combination with rising damp, but other forms of damp can also cause substantial damage.

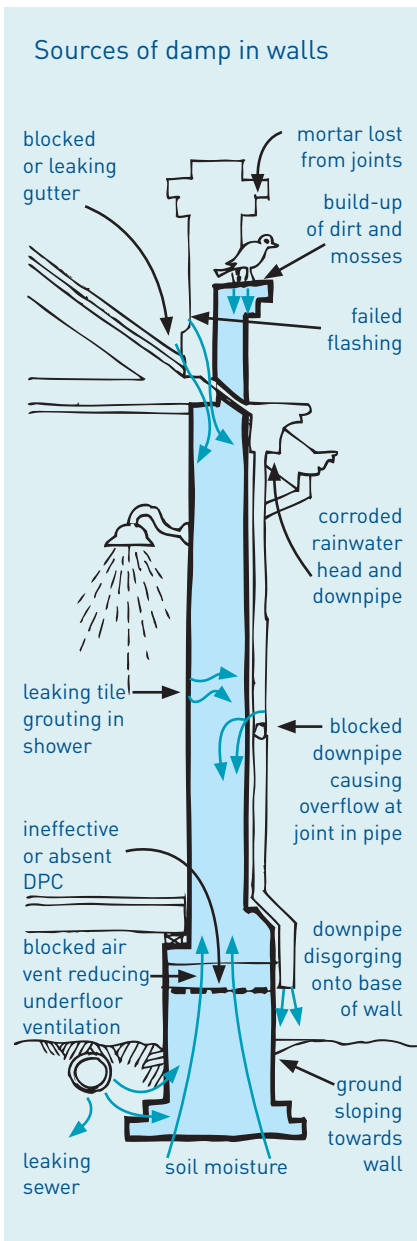
Figure 13 (above) The many sources of damp in walls.

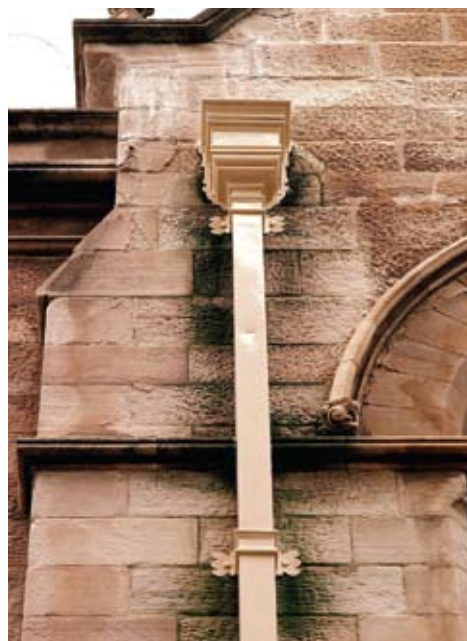
8.2 Penetrating damp

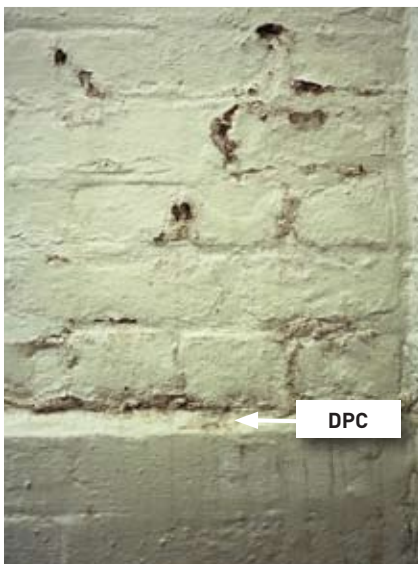
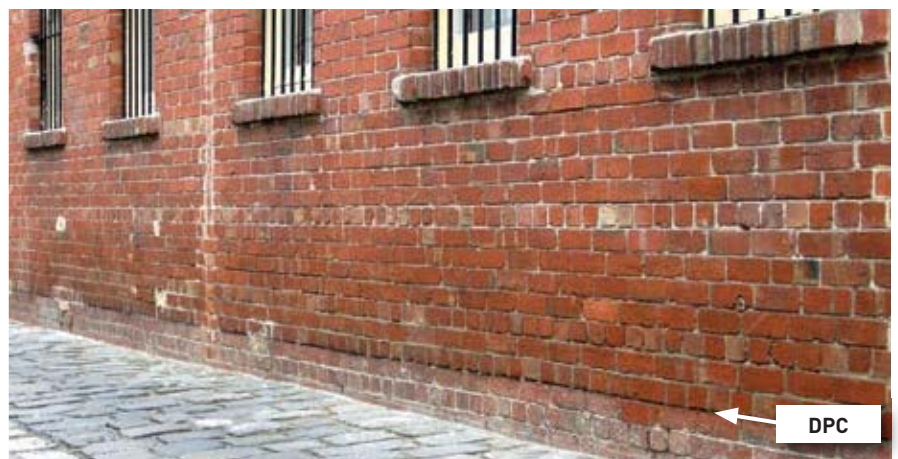
This section begins with the factors causing salt attack and considers rates of decay in Australia in contrast to those of the United Kingdom. Some important considerations in the management of a salt damp problem are then discussed, providing a theoretical basis for the recommended approach and remedial works of Part Two.

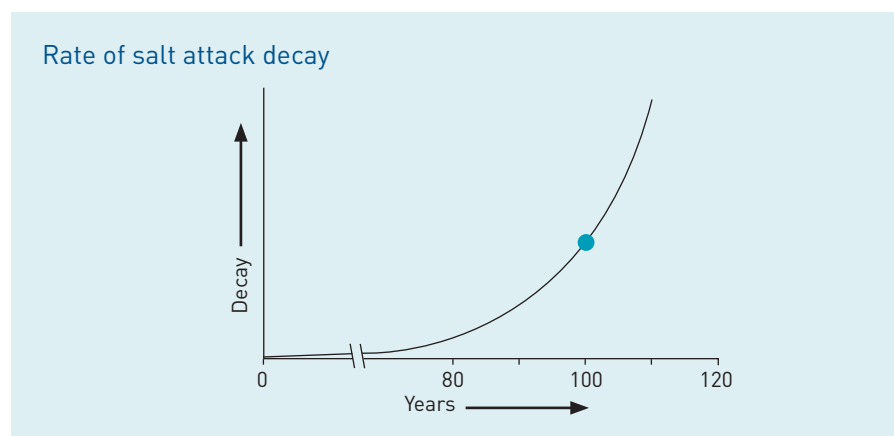
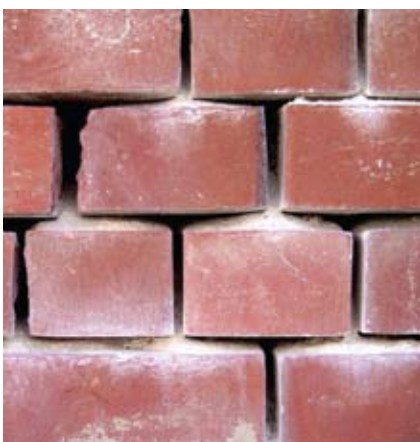
Figure 18 Extensive loss of lime mortar due to salt attack. The bricks remain sound — protected by the weaker mortar. Any further mortar loss risks local collapse of the brickwork. Successful repair may require dismantling and reconstruction as is done when undersetting (See Section 16.1).

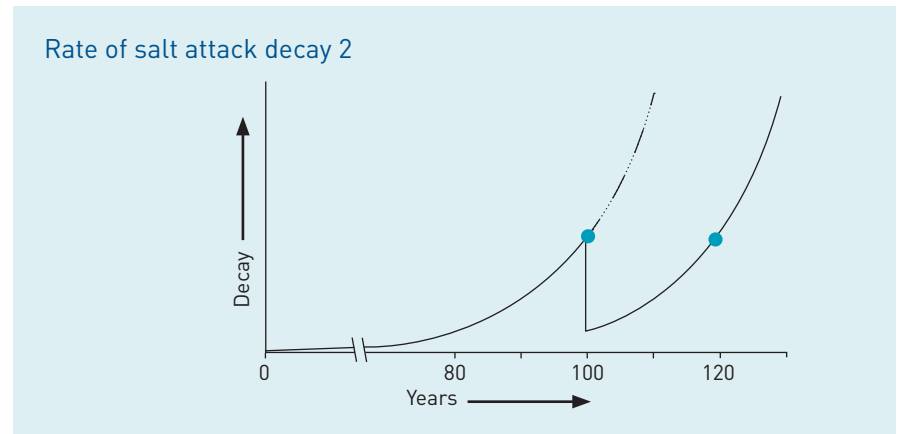
Clearly, this treatment does not cure the salt damp — instead it is a maintenance approach of managing the problem and preventing it from getting worse. Like any maintenance it will require periodic renewal — in this hypothetical case, every twenty years.

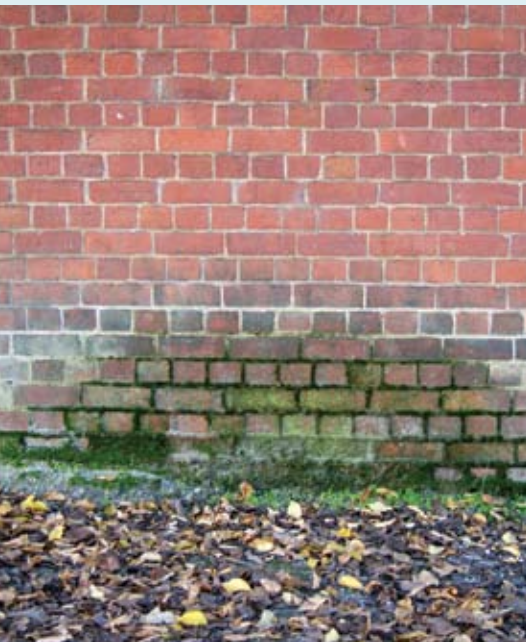
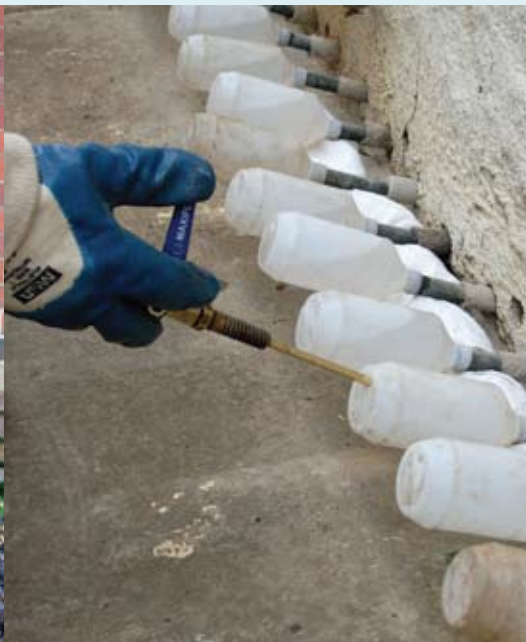
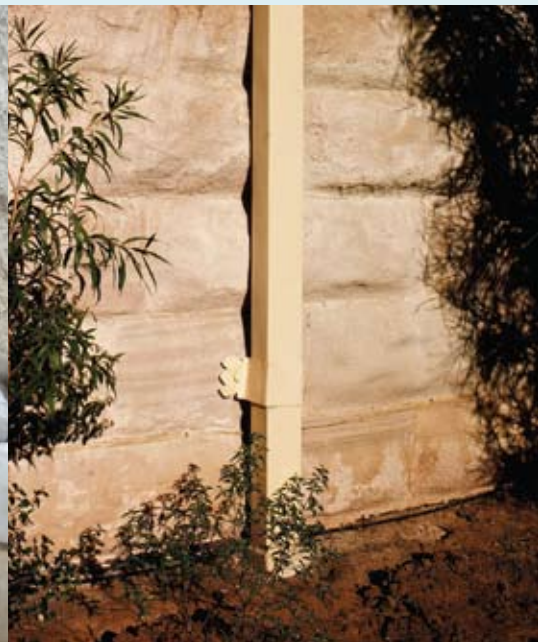
This part of the guide begins with a series of Seven Key Steps which should be followed when dealing with a salt damp problem. These are the steps already outlined in Section 2: *The Basics*. The steps and their section numbers are:

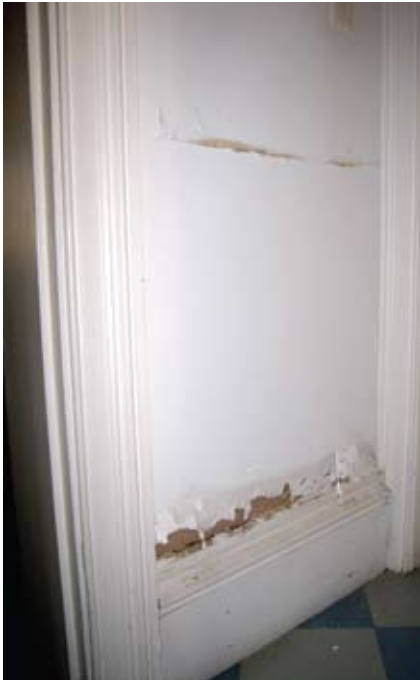
Figure 20 Evidence of previous treatment with hard impermeable plaster. Damp is evaporating from above and below the impermeable zone.

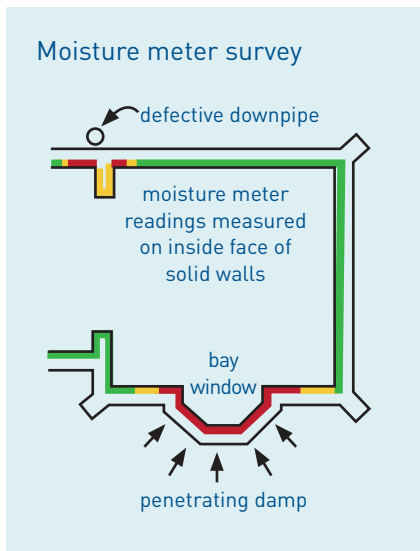
Figure 21 Moisture meter survey with results shown colour coded as on meter; red = high, yellow = moderate, and green = low.

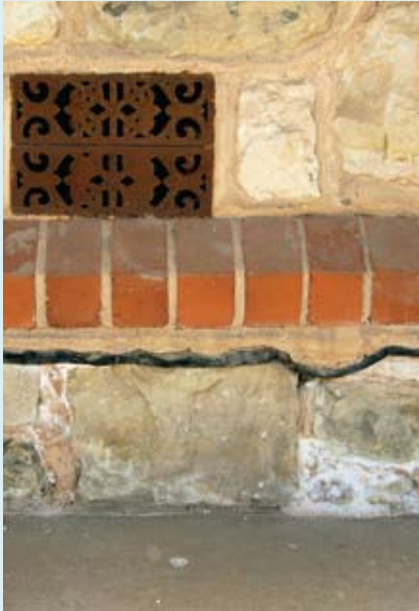
Contaminated materials

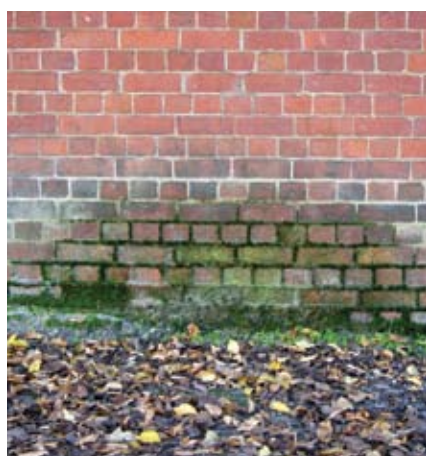
Figure 23 Maintenance, maintenance, maintenance. Here a roof gutter has rusted through and the colourful green damp zone is due to splash.

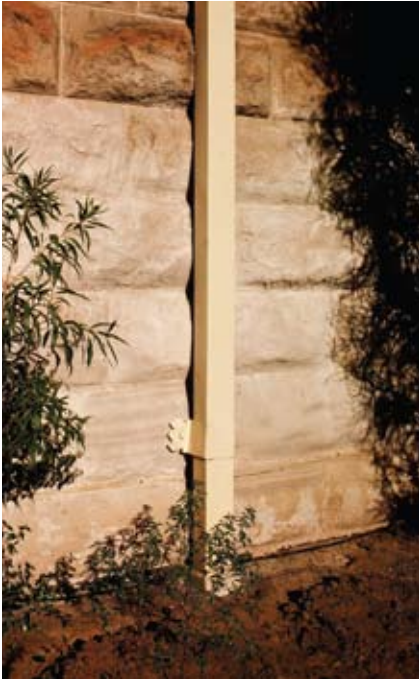
Figure 24 Garden beds against walls almost guarantee salt damp problems. Here the DPC was buried by 300 mm of soil — five courses of sandstone have been severely damaged.

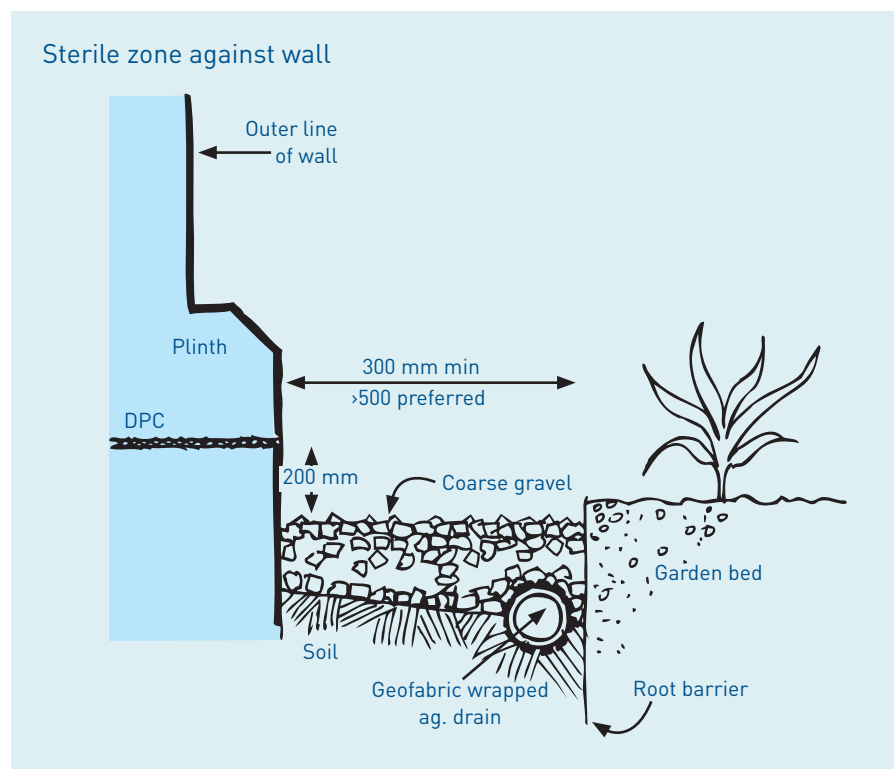
The nature of any paving adjacent to walls is also important. Hard paving contributes to damp problems as it encourages rain to splash up into walls. Further, impervious hard paving will prevent evaporation of soil moisture encouraging it to be transpired via the walls (Figure 28). Coarse gravel is the ideal material for the zone adjacent to old walls as it limits splash from rain while also allowing evaporation of soil moisture (Figure 25). Deliberately permeable paving slabs made of no-fines concrete or resin-bound aggregate offer some potential, although the upper surfaces should be rough and angular to deflect rain strike.

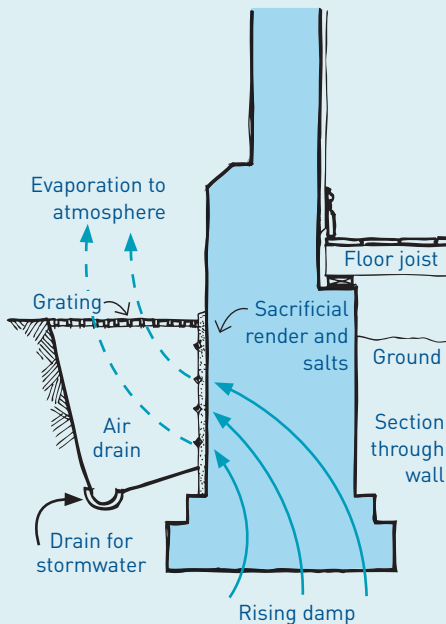
Air drains — a possible control measure

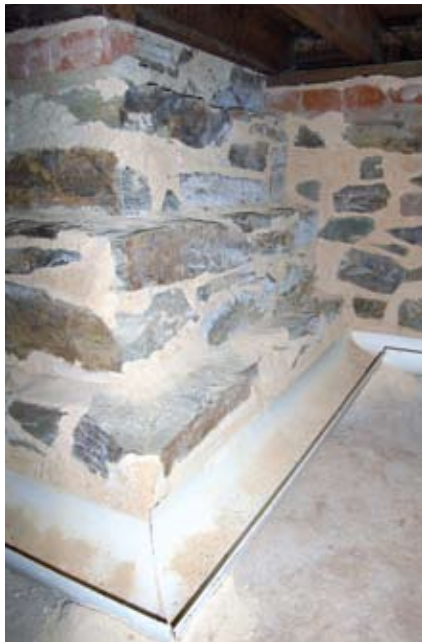
Figure 27 Semi-circular sections of PVC piping catch salt and other debris from sacrificial plasters and mortars on the walls beneath the floor of a church. Bedded on the same sacrificial mortar mix as that used for the walls, the pipes prevent the recirculation of the salts through the soils below and are cleaned out annually. White salts are visible on the stones in the centre of the photograph.

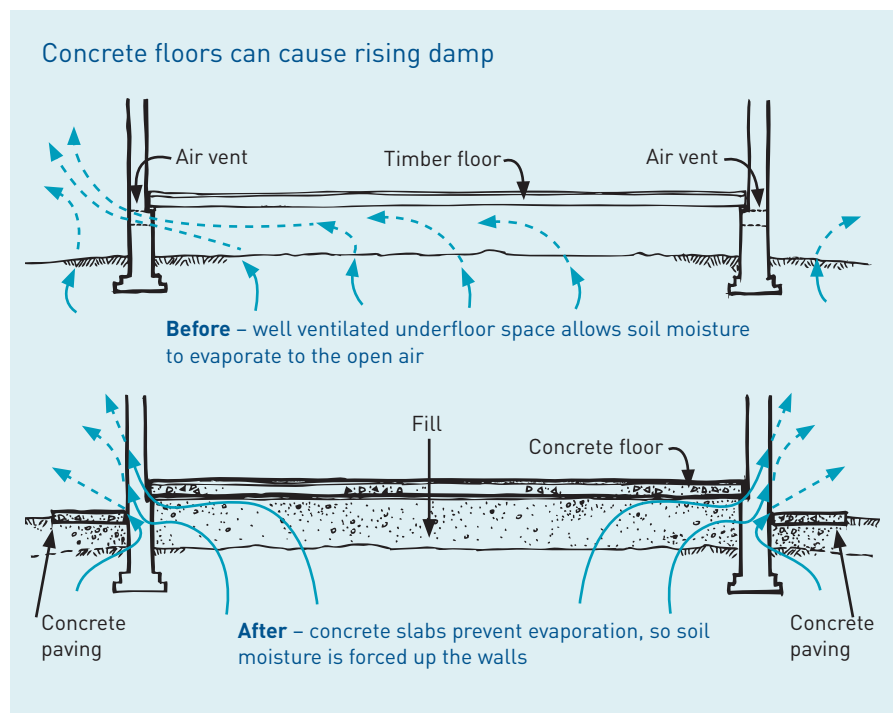
The same effect can often be seen in old houses with tiled or concrete front verandas. Because of absent, bridged or ineffective DPCs, moisture rising beneath the semi-permeable veranda floor is forced up the front wall,

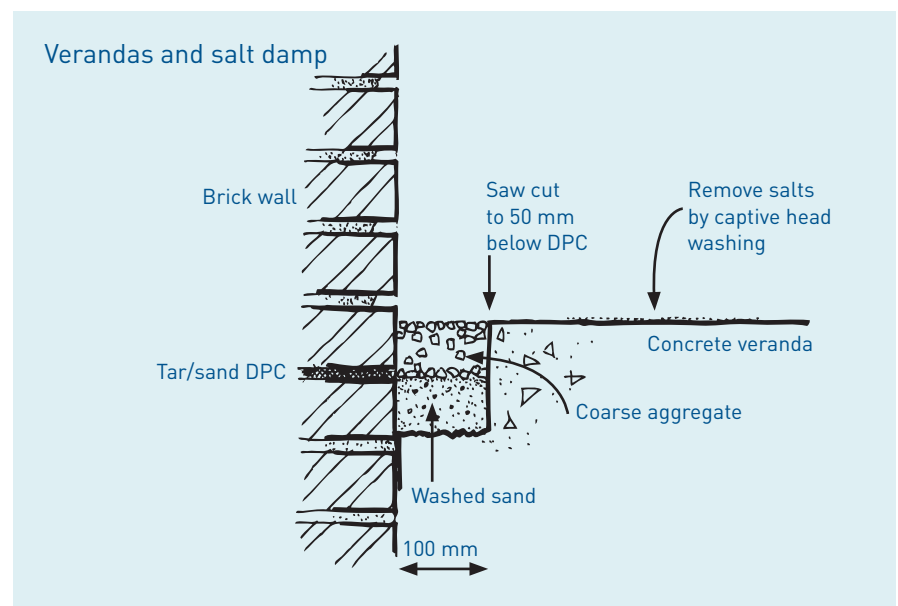
12.5 Repairing a tar and sand damp-proof course

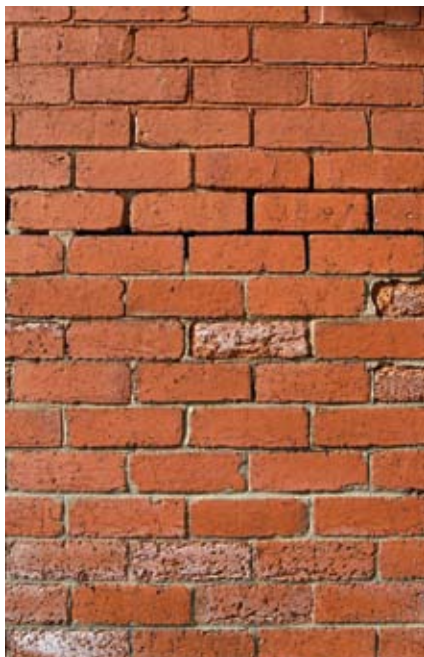
Figure 30 The wrong response to salt damp. Nine courses of brickwork have been repointed in cement mortar, driving the damp even further up the wall and leading to salt attack damage to the bricks. Whereas the original lime mortar was weaker than the bricks and acted sacrificially, the new cement mortar is less permeable, forcing some of the damp to evaporate through the bricks — causing the obvious salt attack decay — and the rest to rise further in the wall. Traditional construction relies on mortars that are weaker than the bricks, partly for the reasons above and also so that any structural cracking will be expressed in the mortar, where it is less obvious and readily patched.

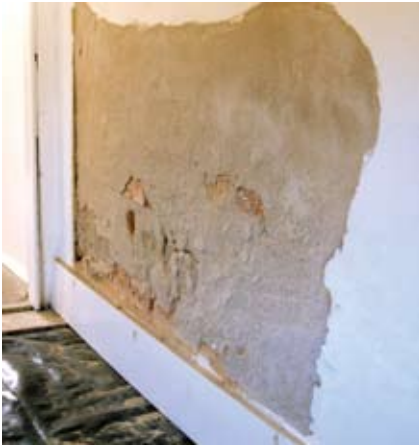
Figure 31 Sacrificial plaster decaying as intended. Plastic sheeting is used to catch the salts and prevent their recycling through the soils and walls.

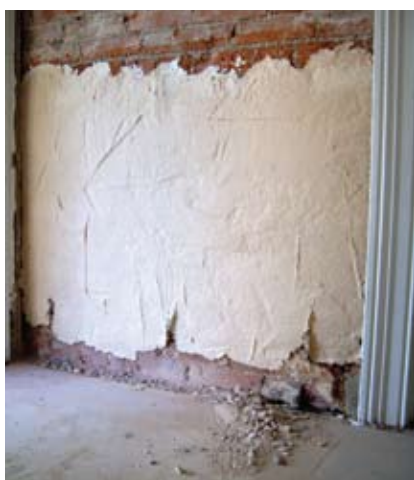
Figure 32 Absorbent poultice shortly after application to an interior wall from which plaster has been removed. The poultice is left on the wall until it is dry, which may take 2–3 weeks depending on weather conditions.

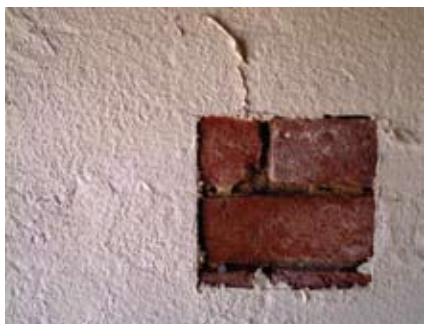
Figure 33 A square section of dried poultrice has been cut out for chemical analysis. Sampling of the same point during subsequent cycles of poultering is aided by a marker such as the galvanised nail in the bottom left of the 'window'.

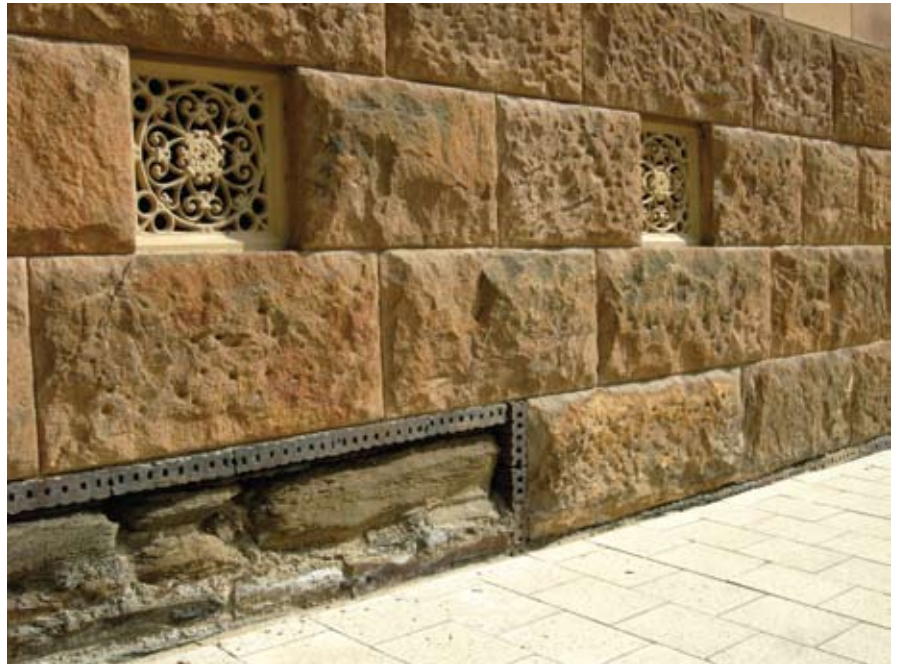
The position of the new DPC in relation to ground level and to floor timbers is important; advice on these aspects is given in Box 2: *Location of damp-proof courses* and Section 19: *Inserting chemical DPCs in internal walls*.

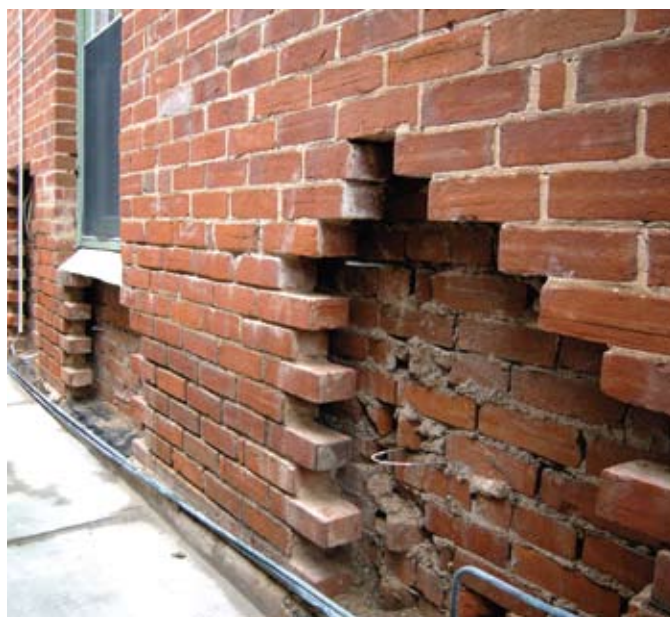
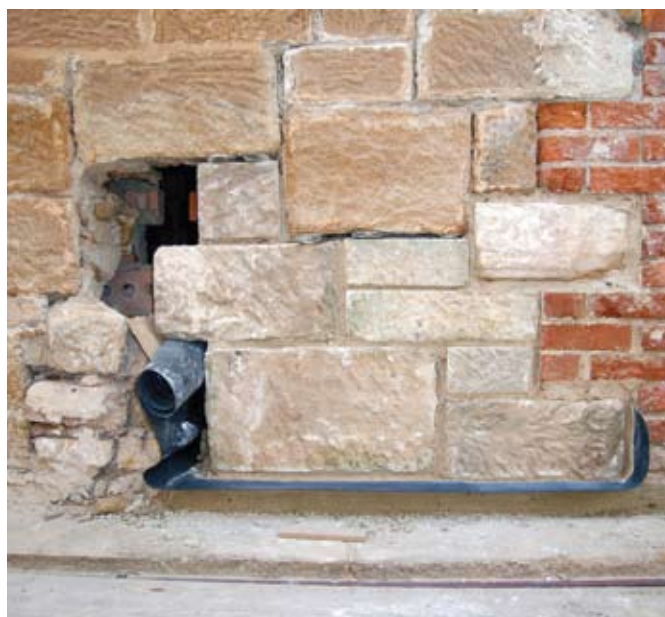
Undersetting is skilled work requiring great care. Do not attempt it without specialist advice. Undersetting of high walls may need structural engineering advice. While it may look precarious, the high compressive strength of masonry materials means that the load of a wall can be supported on the remaining brickwork despite the removal of a substantial proportion. In some cases, particularly in thick walls of rubble masonry, it is necessary to provide additional support for the overlying wall while sections are being rebuilt.

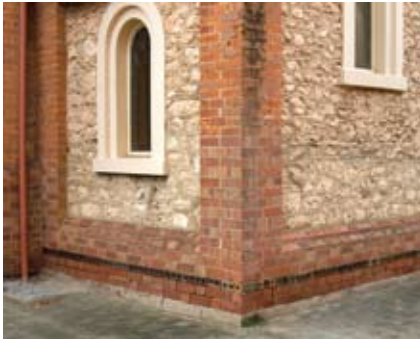
Figure 37 Undersetting from the 1930s. New bricks and stones have been inserted up to a line above the window sill on the left. Bricks below the DPC are visibly damp (see also Figure 10).

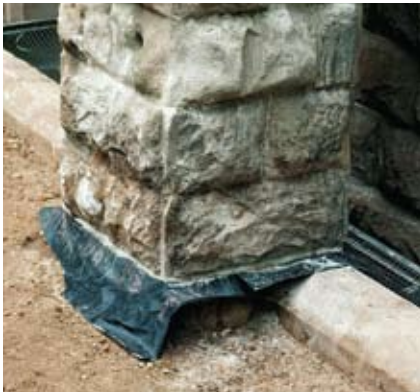
Figure 38 Insertion of a DPC by slot sawing. A mortar joint is sawn out with a chainsaw allowing insertion of DPC sheeting. As salt-laden stone is left above the DPC, the technique must be combined with desalination to be successful.

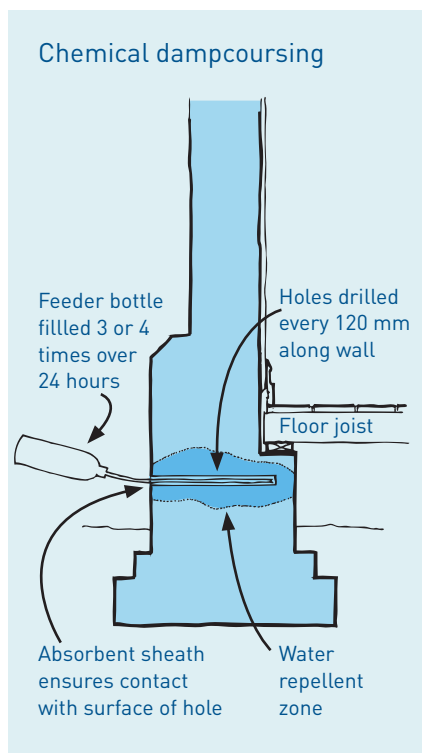
Figure 39 Chemical dampcoursing. Cross-section through a solid wall showing the gravity-fed system. Note that the new water-repellent zone should be installed below all floor timbers.

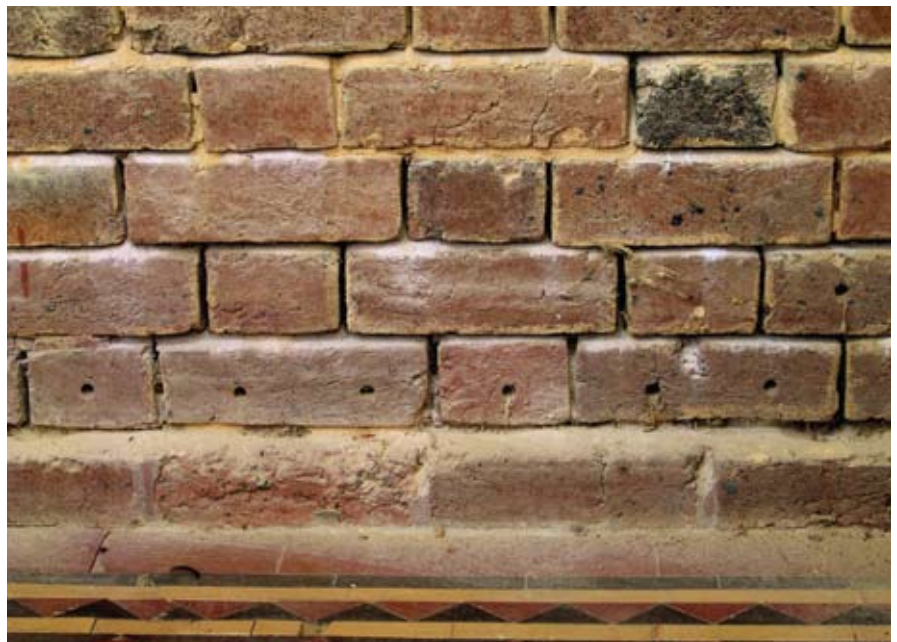
16.4 Active electro-osmosis

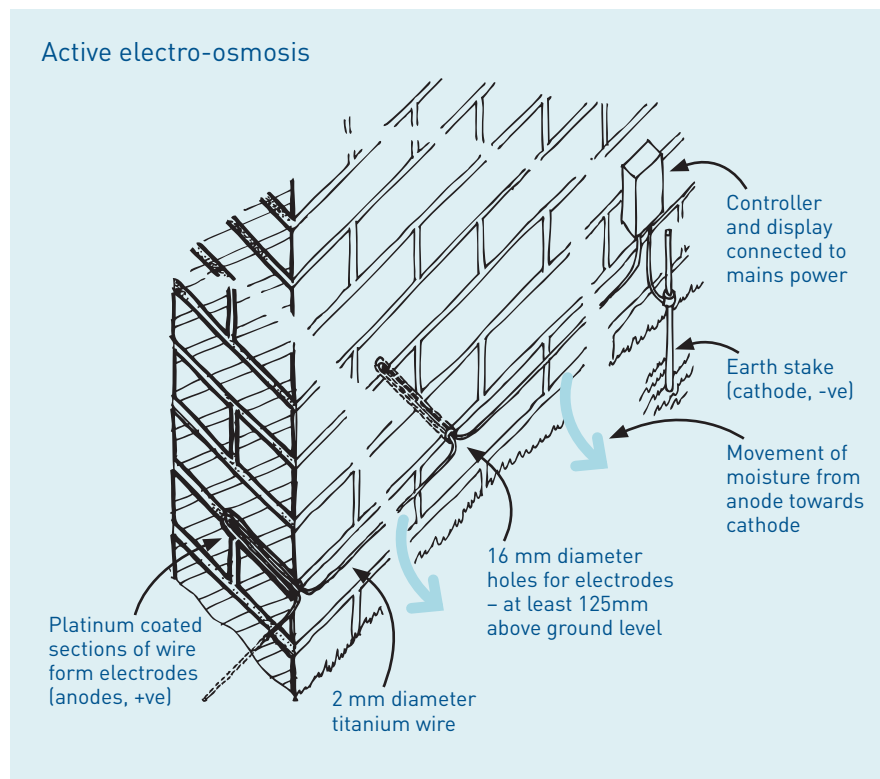
The following should be considered when contemplating active electro-osmotic treatment of rising damp:

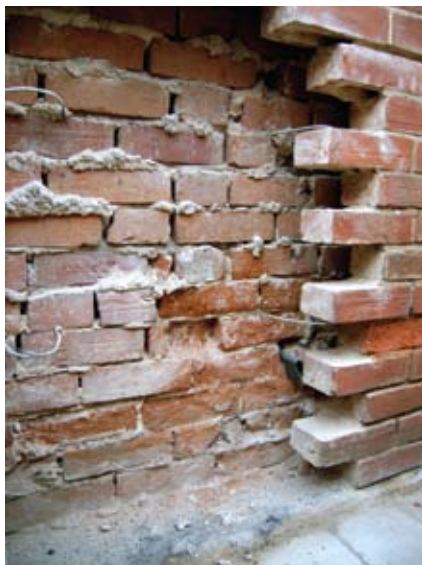
Figure 45 Decay of an inner leaf of brickwork into the cavity. This would not have been discovered had the wall not been opened up for undersetting of the outer leaf. The decay means that evaporation is occurring in the cavity in preference to the interior of the house. Multiple paint coatings or previous repairs of interior plasters with dense impermeable materials may be an explanation. Whatever the cause, the implications of decay occurring where it cannot be seen are profound. The inner leaf must be treated, using one of the methods described in this guide.

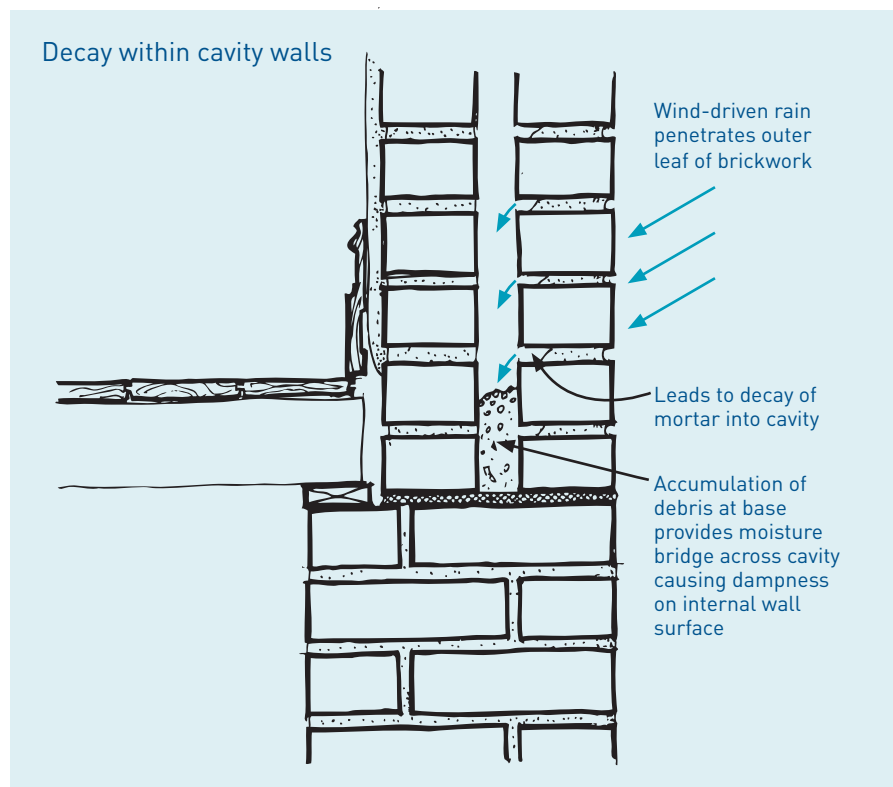
Figure 46 Section through a cavity wall showing deterioration of the inside face of the outer leaf due to moisture penetration through the brickwork. Such decay is more likely where the wall has been sandblasted, making the outer surface more permeable, and where the DPC is not effective, allowing rising damp to compound the problem. Even with a perfect DPC, decay into the cavity may be a problem, particularly near the coast where sea spray carries salt into walls.

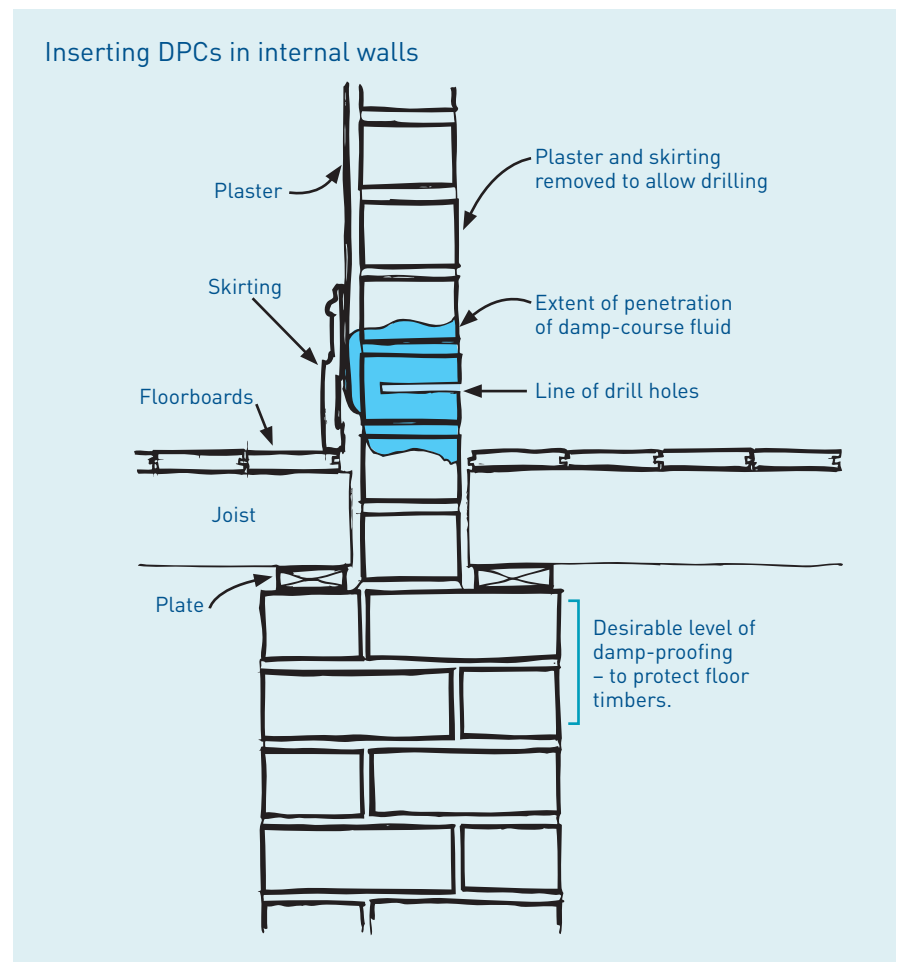
Best practice DPC insertion would therefore require the removal of sufficient floorboards to enable working access to the wall so that it can be injected (or slot sawn) below floor level. This will obviously add to the expense and disruption of the job. (Note that there are practical difficulties with injecting the upper course or slot sawing in the first mortar joint below the floor plate, as the upper course of bricks will be loosened by vibration. Drilling, or slot sawing, would need to be in the second or third course or joint, respectively.) There may be additional complications if the wall below floor level is not made of regular brickwork but of dense stone such as bluestone or granite, which may make DPC insertion difficult. A less expensive alternative, but one which would still provide protection to both masonry and timber, is explained below.

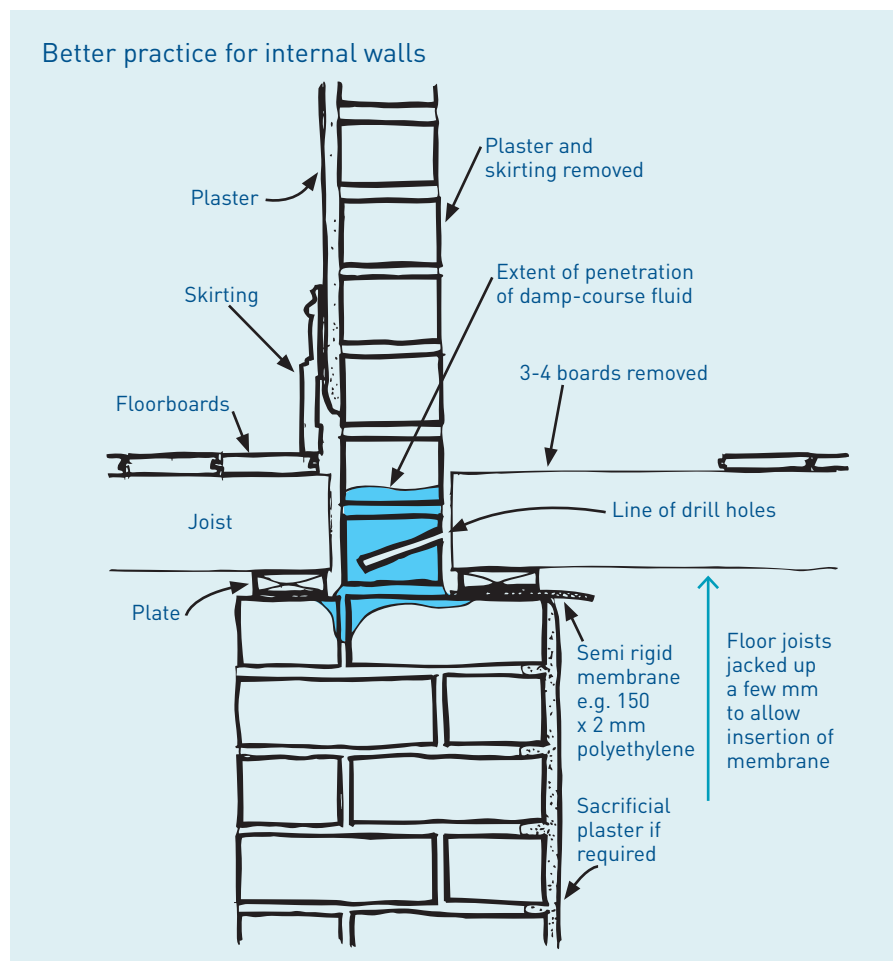
The mortar joint immediately above the wider masonry (and directly below the brick being drilled) is where we would expect to find a DPC. A partially effective DPC (e.g. of tar and sand) at this joint will limit downward penetration of the fluid. Drilling and impregnating an existing tar and sand DPC would be counter-productive and should never be undertaken. Impregnation adjacent to a tar and sand DPC creates the risk of staining as solvents in the fluid dissolve components of the tar, although this shouldn't be an issue for interior walls that are to be replastered.
