Salt attack and rising damp

A guide to salt damp in historic and older buildings

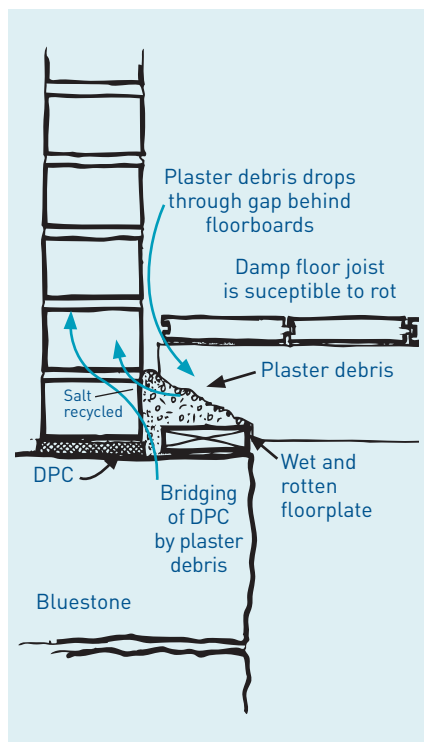
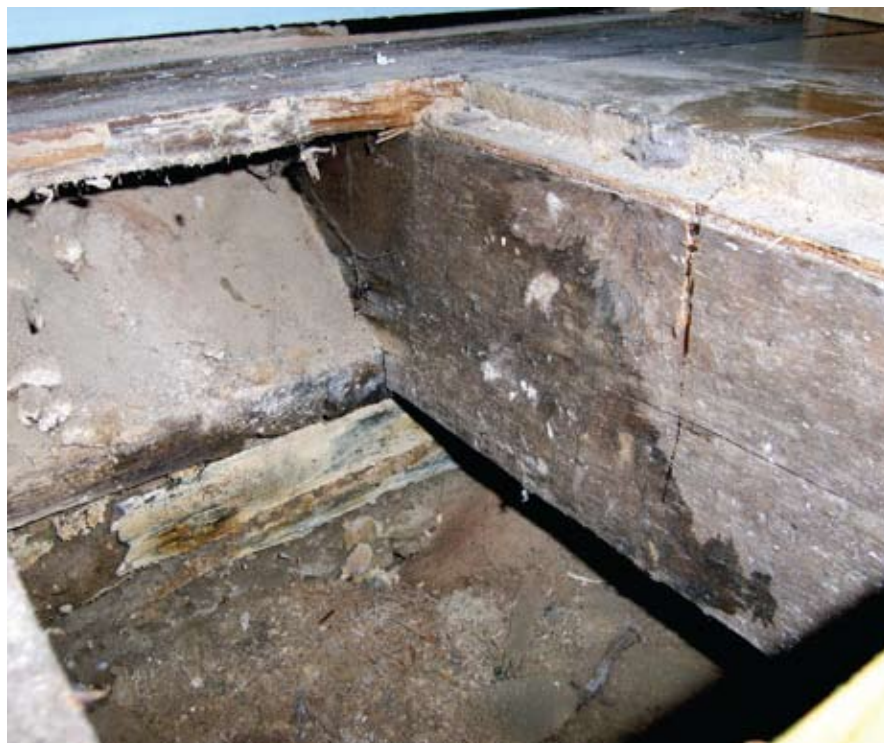
Figure 50 shows a similar view beneath the floor of another house. Salt attack is decaying the brickwork and the debris is accumulating on the damp floor plate. The brick debris overlies previous plaster material which has fallen onto and behind the plate, thereby making a bridge across the DPC which is located out of sight, directly behind the floor plate. Unfortunately the plate is not isolated from the damp masonry below, a situation that is common in Australian buildings. Note the extensive salt efflorescence on the face of the bluestone rubble.

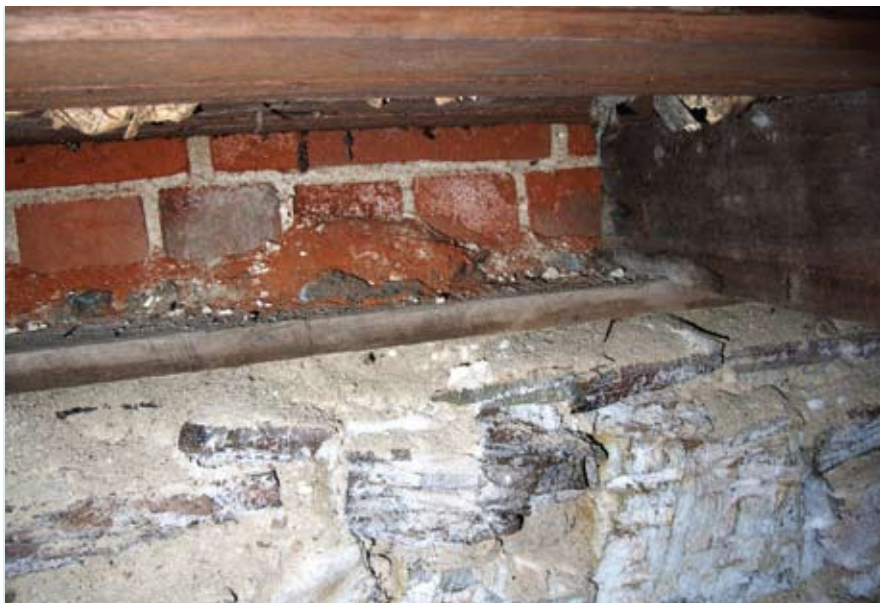
The problem of accumulation of plaster debris on floor plates is widespread and is likely to be encountered wherever repairs to plasterwork have been undertaken.

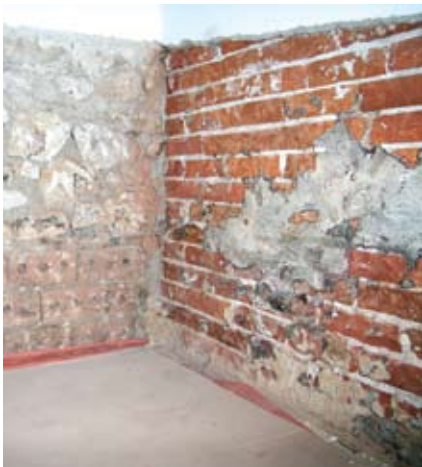
Figure 51 Discoveries on removing plaster from interior walls. On the left, the brick-on-edge is a partial undersetting of the inner part of a solid wall, leaving the outer part untreated — a total waste of effort. On both walls, but more apparent on the right, are remnants of a dense hard cementitious material containing milled iron that was designed to rust and block pores, making it impermeable. Its removal proved extremely difficult.

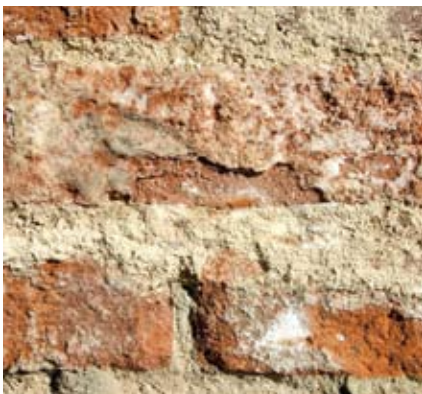
Figure 52 A thick film of salt that crystallised beneath a hard render, which was in turn finished with a high-build (thick) paint coating. For evaporation (and hence salt crystallisation) to occur the render must first have become partially detached from the brickwork. Thermal cycling would then drive air movement, allowing evaporation. The salt was chiselled off and the brickwork poulticed before re-rendering.

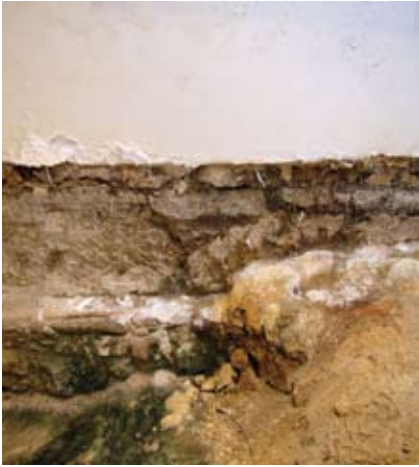
Figure 53 Damaged plaster on a damp wall; the dampness is indicated by green algae and white salts crystallising on the stonework and fill below. The recent plaster is decaying because it contains gypsum.

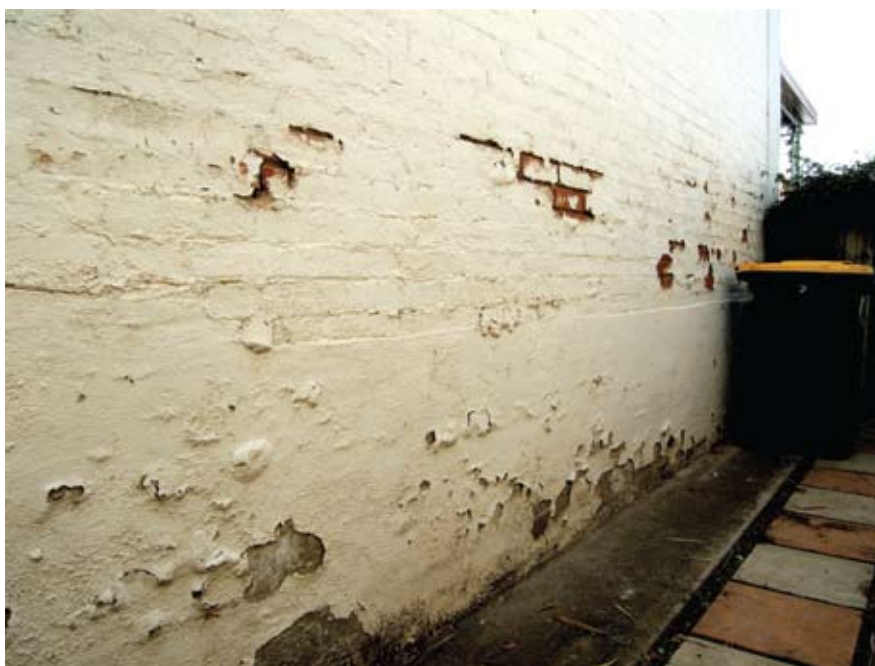
Buildings of heritage value that were traditionally painted in limewash should be repainted in limewash, not only because it is the authentic finish, but because it has the greatest breathing capacity of all coatings.

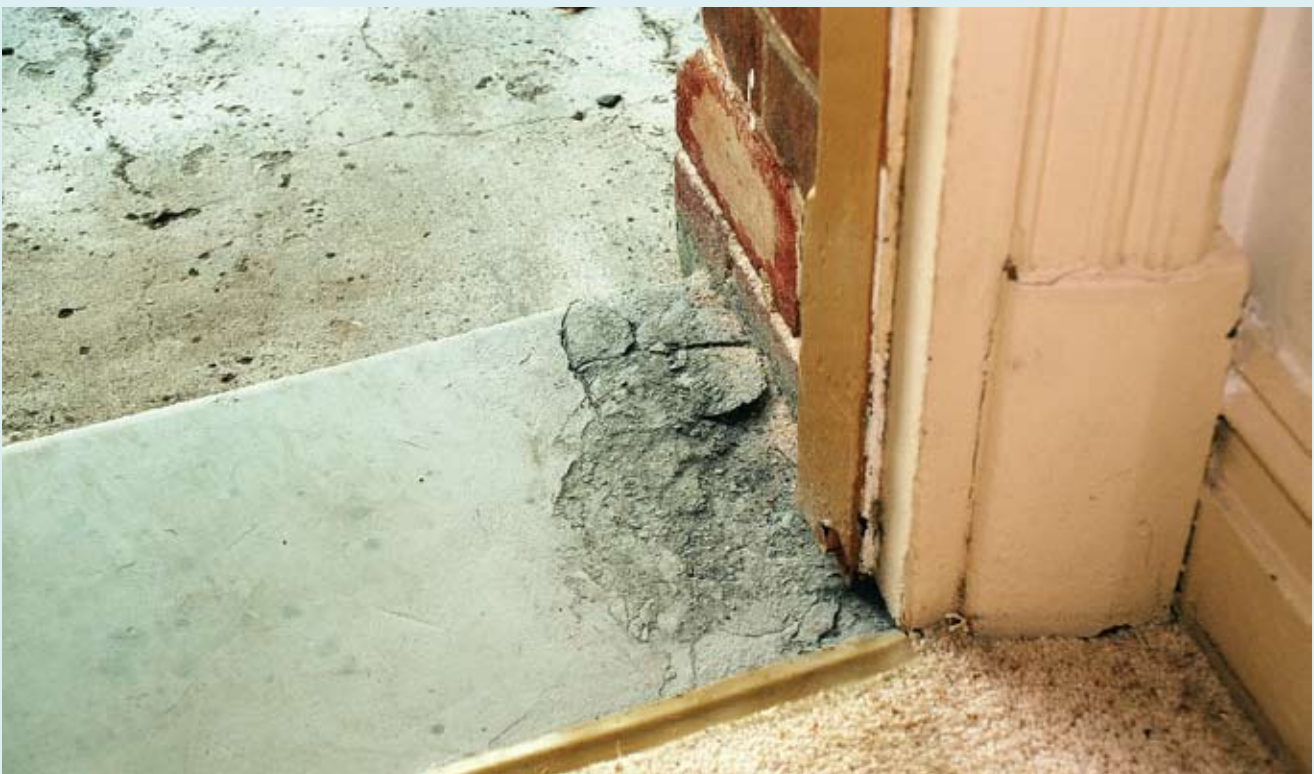
The third step, which is now doing fine after ten years, had its edges sealed with slate sealer prior to installation (several coats of siloxane dampcourse fluid would be an alternative). The new step is bedded on a plastic DPC and on weak mortar that will decay sacrificially in preference to the adjacent brickwork.
