ANNUAL REPORT FOR THE CHIEF INSPECTOR OF COAL MINES

FOR THE YEAR ENDED 30TH JUNE, 1985.

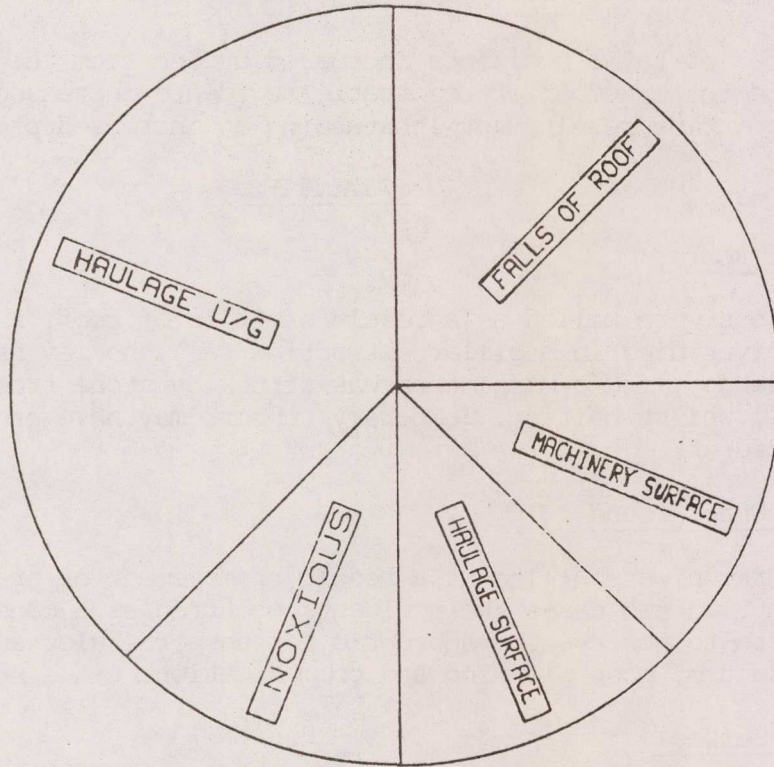
FATAL ACCIDENTS 1984/1985

FALLS OF ROOF:
2 (25.0%)
HAULAGE U/G:
3 (37.5%)
NOXIOUS:
1 (12.5%)
HAULAGE SURFACE:
1 (12.5%)
MACHINERY SURFACE:
1 (12.5%)

The accompanying charts depict fatal and serious accidents by agency for the period.

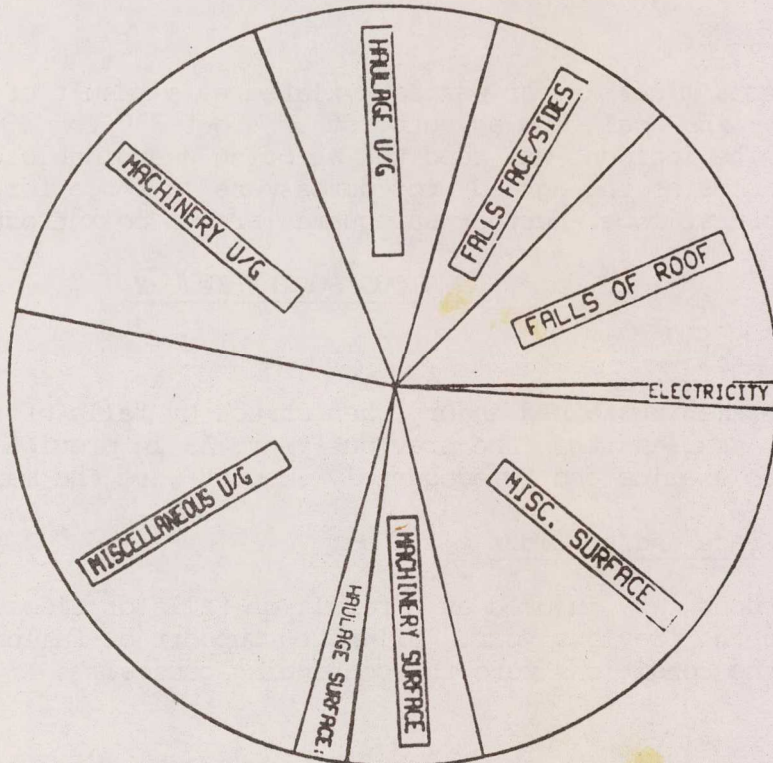
SERIOUS ACCIDENTS (1984/1985)

FALLS OF ROOF:
11 (12.5%)
FALLS FACE/SIDES:
7 (8.0%)
HAULAGE U/G :
9 (10.2%)
MACHINERY U/G :
14 (15.9%)
MISCELLANEOUS U/G :
21 (23.9%)
HAULAGE SURFACE:
2 (2.3%)
MACHINERY SURFACE:
5 (5.7%)
MISC. SURFACE :
10 (20.5%)
ELECTRICITY SURFACE:
1 (1.1%)

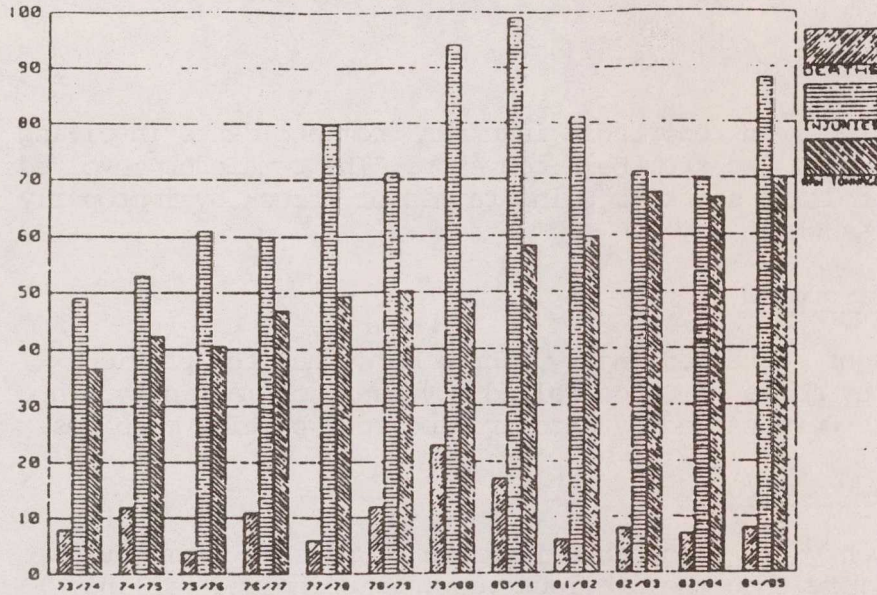
COLLIERY ACCIDENT STATISTICS

DEATHS, INJURIES, OUTPUT (MILLION TONNES)

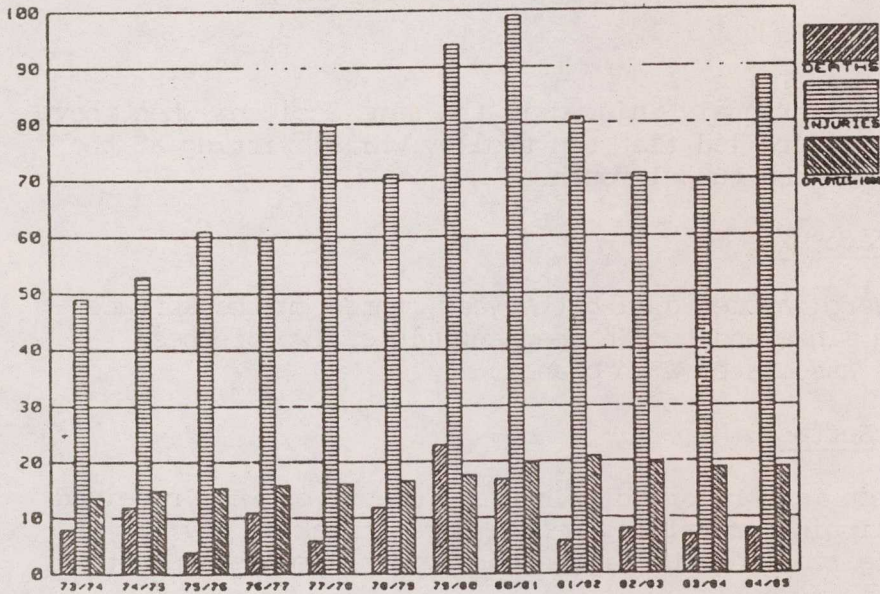
COLLIERY ACCIDENT STATISTICS

DEATHS, INJURIES, TOTAL EMPLOYEES

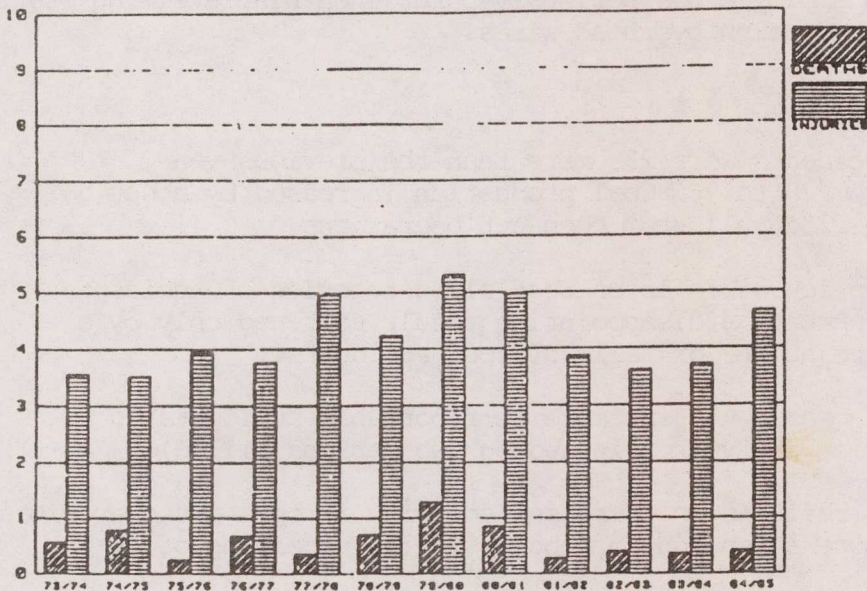
COLLIERY ACCIDENT STATISTICS

DEATHS, INJURIES, PER THOUSAND EMPLOYEES

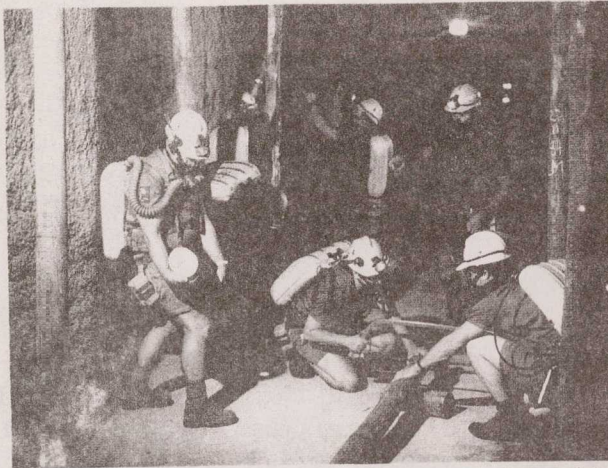
The realistic design of the Mine Simulator allows actual pit work to be carried out. Here a team sets timber during a training session.

The redevelopment of the Newcastle Station was completed during the year. A feature of the new station is the underground training gallery where mine situations can be readily and realistically simulated.

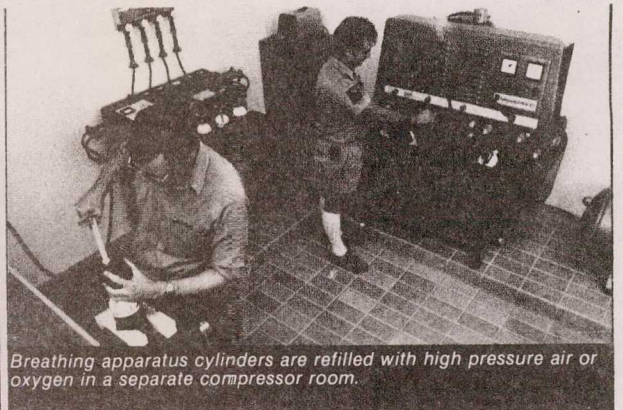
Mines Rescue Team under training, shown here filling liquid oxygen into their breathing apparatus sets prior to a practice at the Station.

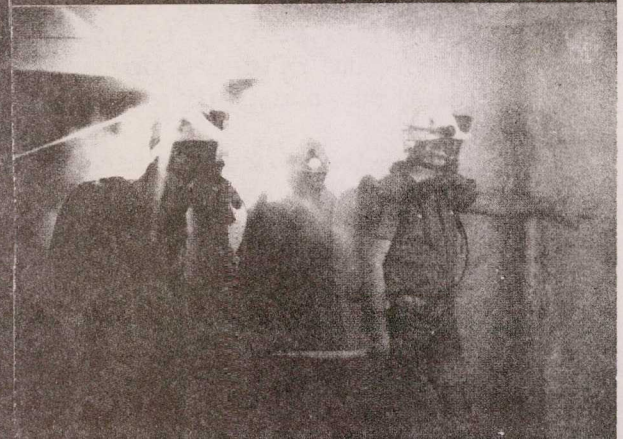
Team under training in the Mines Simulator. Real mine conditions, including smoke, heat and flooding can be created in safety.
