# NSW Alpine Resorts Environmental Performance Report 2016–2019

ISSN 2652-7960 (online)  
EES 2020/0416  
December 2020

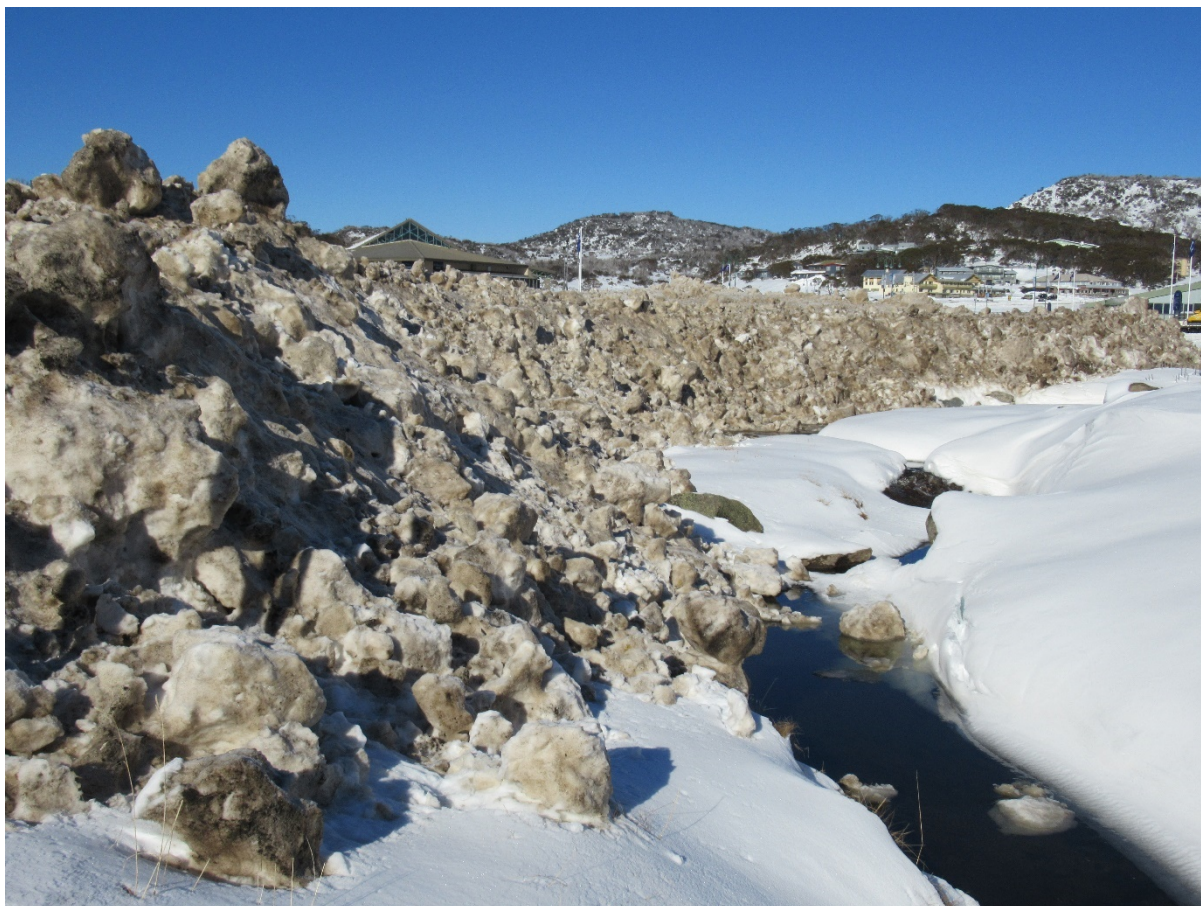
**Figure 3** Snow push from the Perisher carpark into the Perisher Creek  
Photo: T Scanlon/DPIE

- The asphalt removed from carpark surfaces, an unintended consequence of snow clearing activities, remains an ongoing issue for the resorts and NPWS. The Perisher snow clearing manual has been reviewed, with additional snow stockpile areas identified to minimise potential impacts in the waterways and riparian areas. This will require NPWS to continue to monitor the stockpiled snow sites.

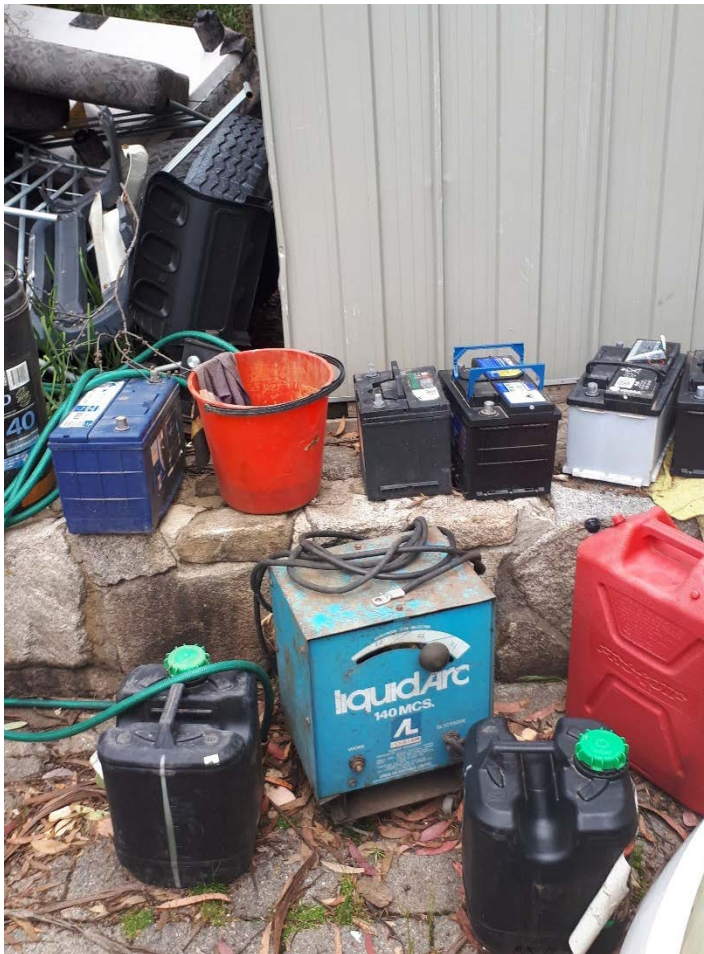
**Figure 4** Incorrect storage of lead batteries and petroleum products.  
Photo: P McCarthy/DPIE
